**ACTON/WEST BASIN • CANBERRA
CULTURAL HERITAGE STUDY**

**VOLUME 2
CONSERVATION ANALYSIS
Illustrated Chronology • Sequential Site Plans**

**FREEMAN COLLETT & PARTNERS PTY LTD
MALCOLM MUNRO & ASSOCIATES
ROGER HOBBS
VIVID HISTORIES • CANBERRA**

AUGUST 1993

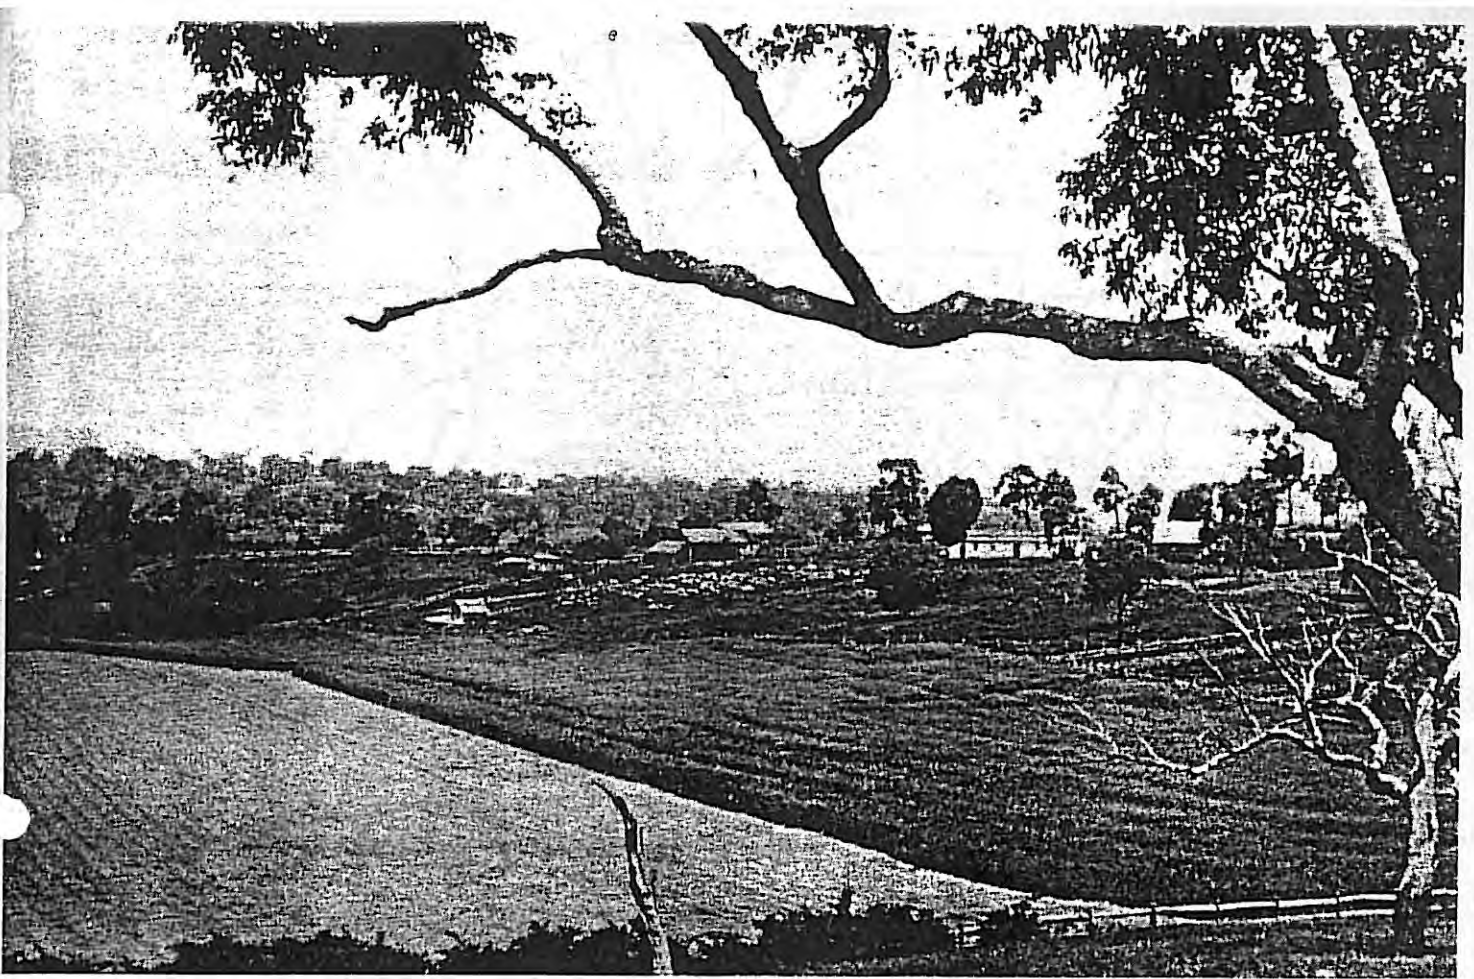
Figure 5
Acton, 1890, Charles Kerry Photograph
Source:
from E Lea Scarlett *First Light on the Limestone
Plains*, 1986

The photograph is taken from the North East
(refer Analysis drawing below) and shows the
Acton buildings along the ridge

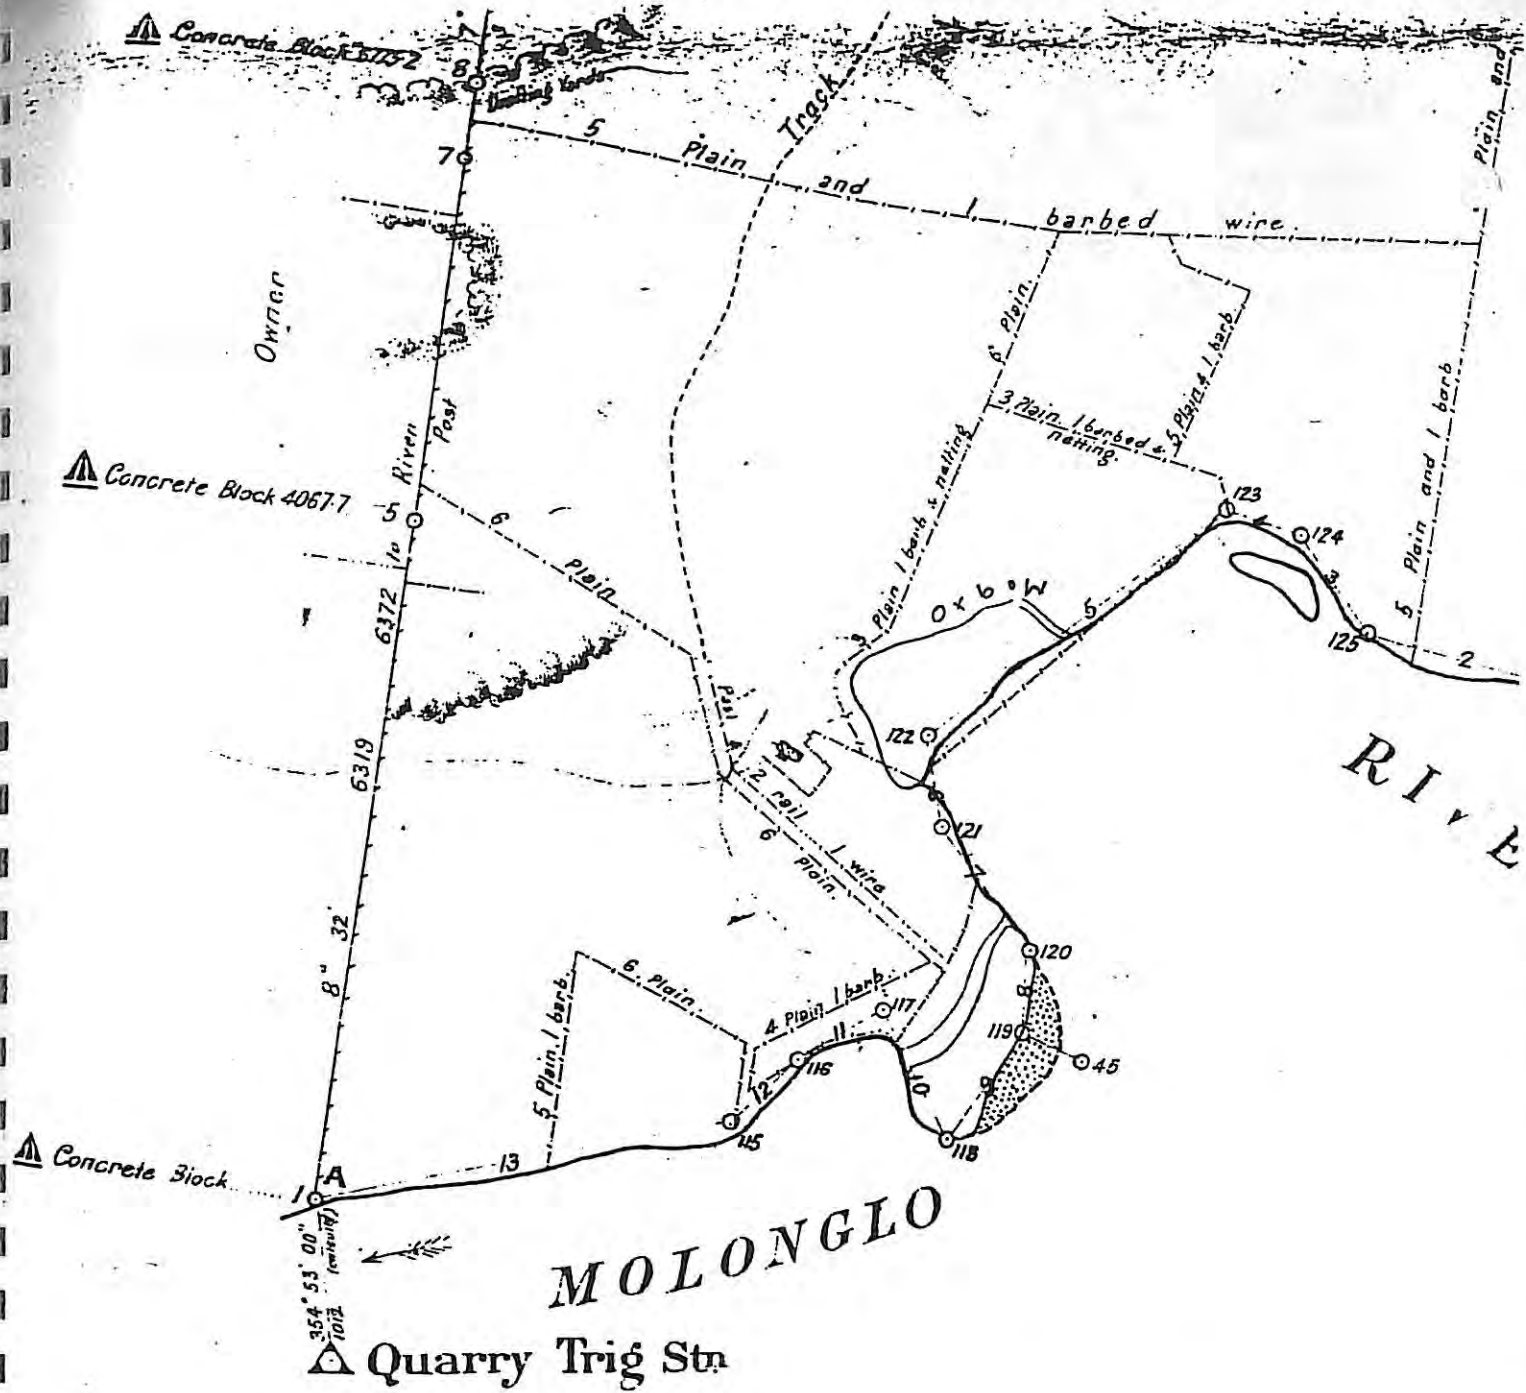
Figure 1
 Survey Map of Acton for purposes of acquisition,
 c 1911, by Licensed Surveyor R.J. Rain.
 Source:
 Australian Archives A192FCL/1416

Note that there appears to be no crossing at the end of the peninsula. The parallel fencing is a track on Acton property.

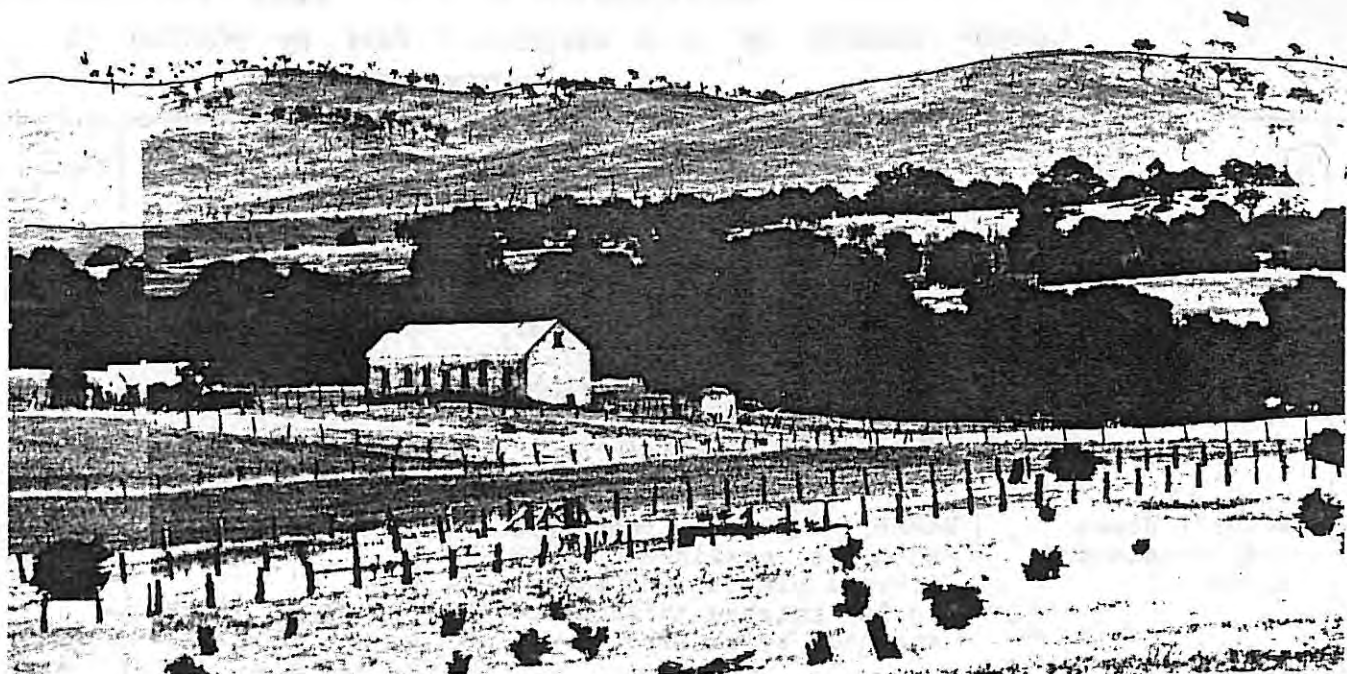
Figure 7
Klensendorffe's Elizabeth Farm, centre, with
the road to Lennox Crossing and Acton in the
foreground, c 1913.
Source:
NLA Canberra

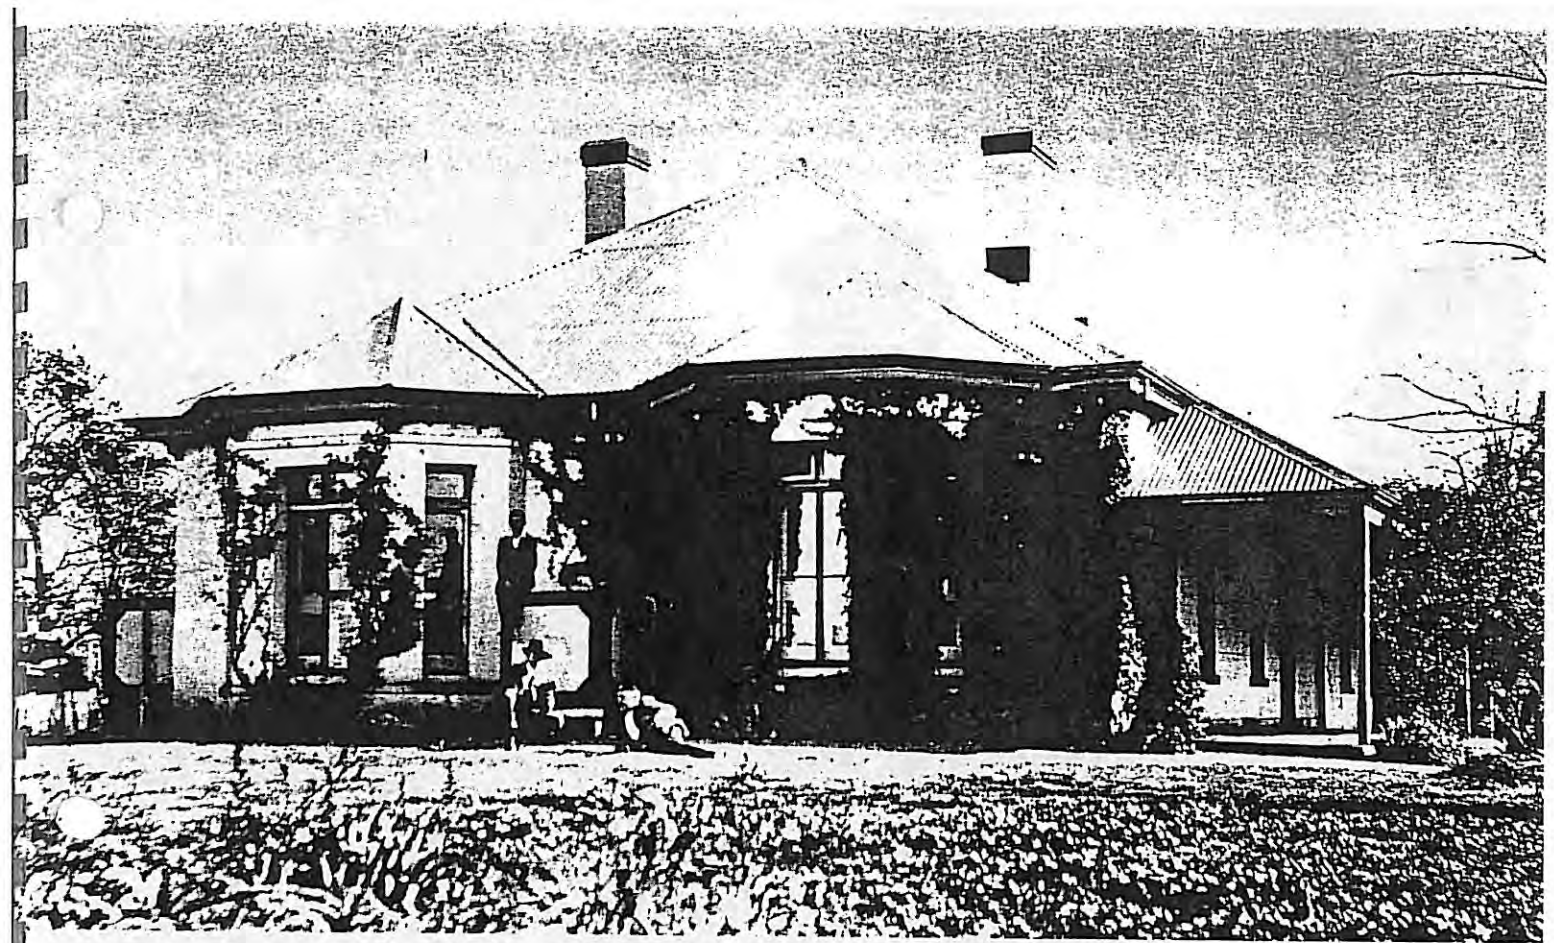
Top
Figure 11
Acton House in 1915.
Source:
From Fitzgerald, *Canberra in Two Centuries*

The House from the South East just after its resumption by the Department of Home Affairs.

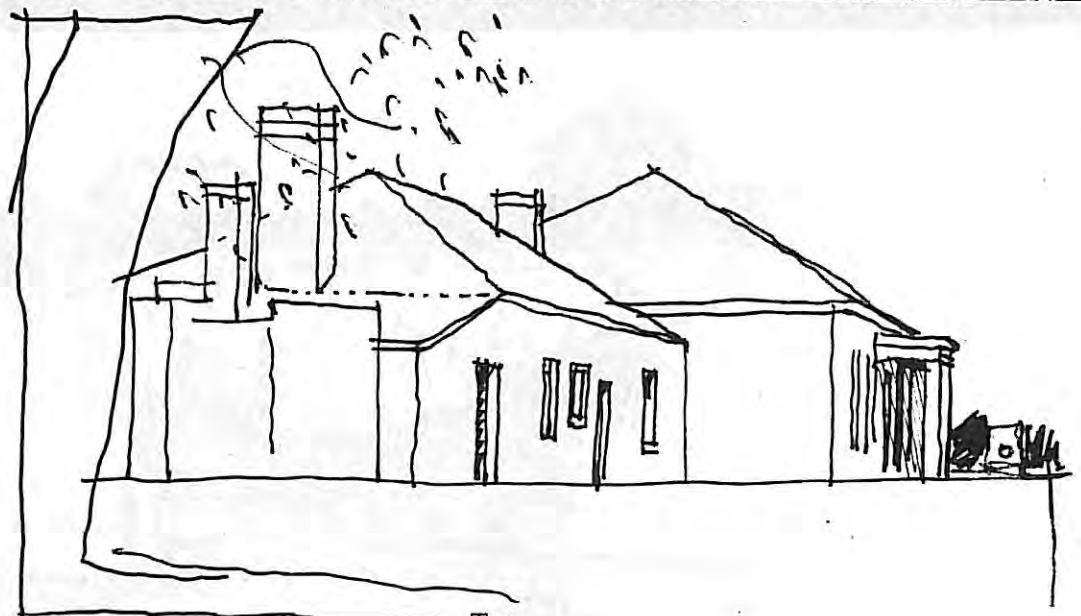
Bottom
Figure 12
Acton House c 1920 from the West. Line drawing over photograph.
Source:
From Fitzgerald, *Canberra in Two Centuries*

The original cottage (foreground) has lost its verandah. The Brassey addition had a formal central portico which faced on to the Lennox Crossing Road.

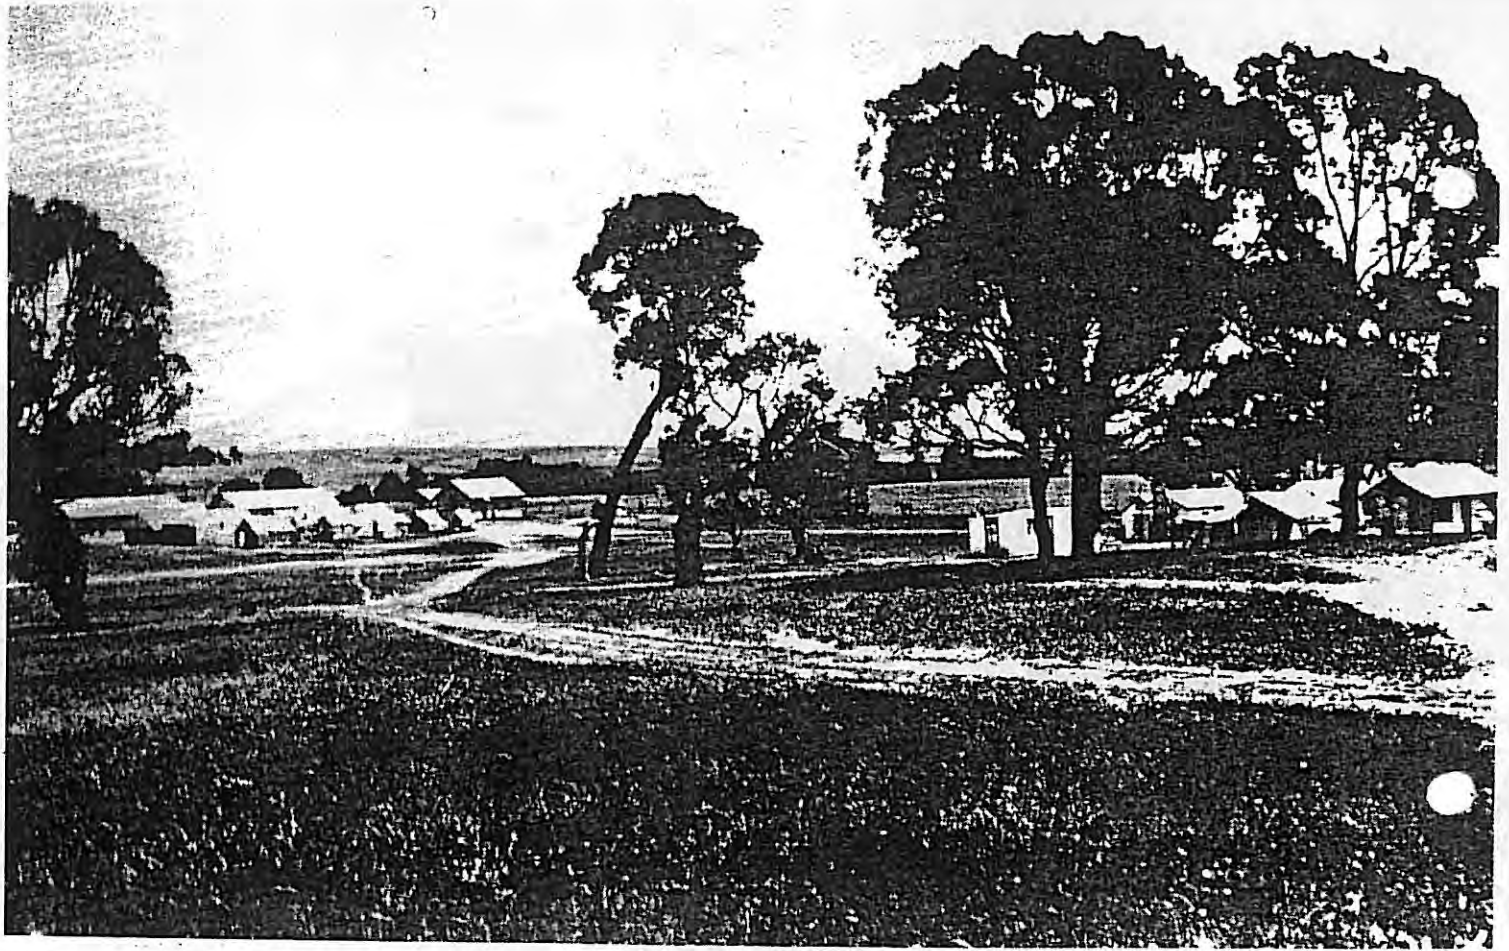
Top
Figure 15
The Acton Mess, Workmen's Camp, c 1913.
Source:
From Gibbney, *Canberra 1913-1953*

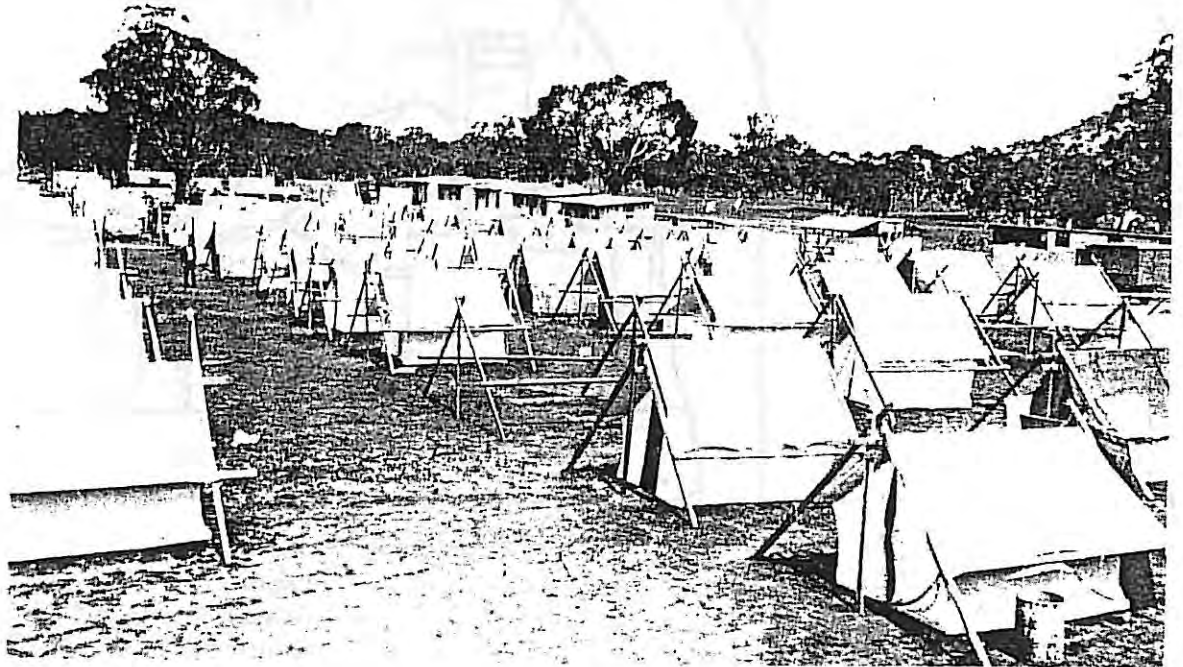
Bottom
Figure 16
Workmen's encampment at Acton 1912.
Source:
From Gibbney, *Canberra 1913-1953*

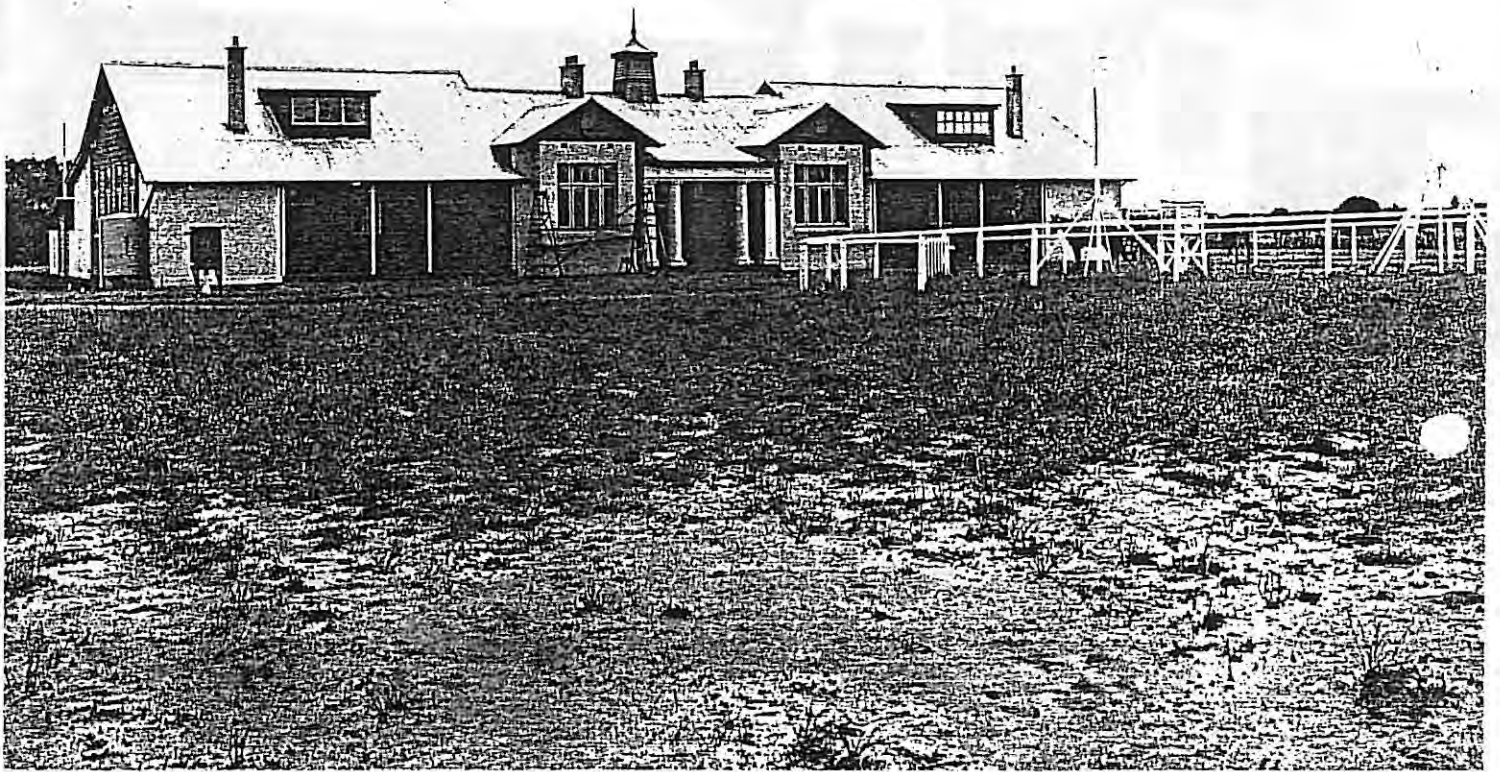
Figure 14a
The Administrative Building, Department of
Home Affairs, Acton, c 1912
Source:
NLA Canberra, F W Robinson Collection,
MS5859

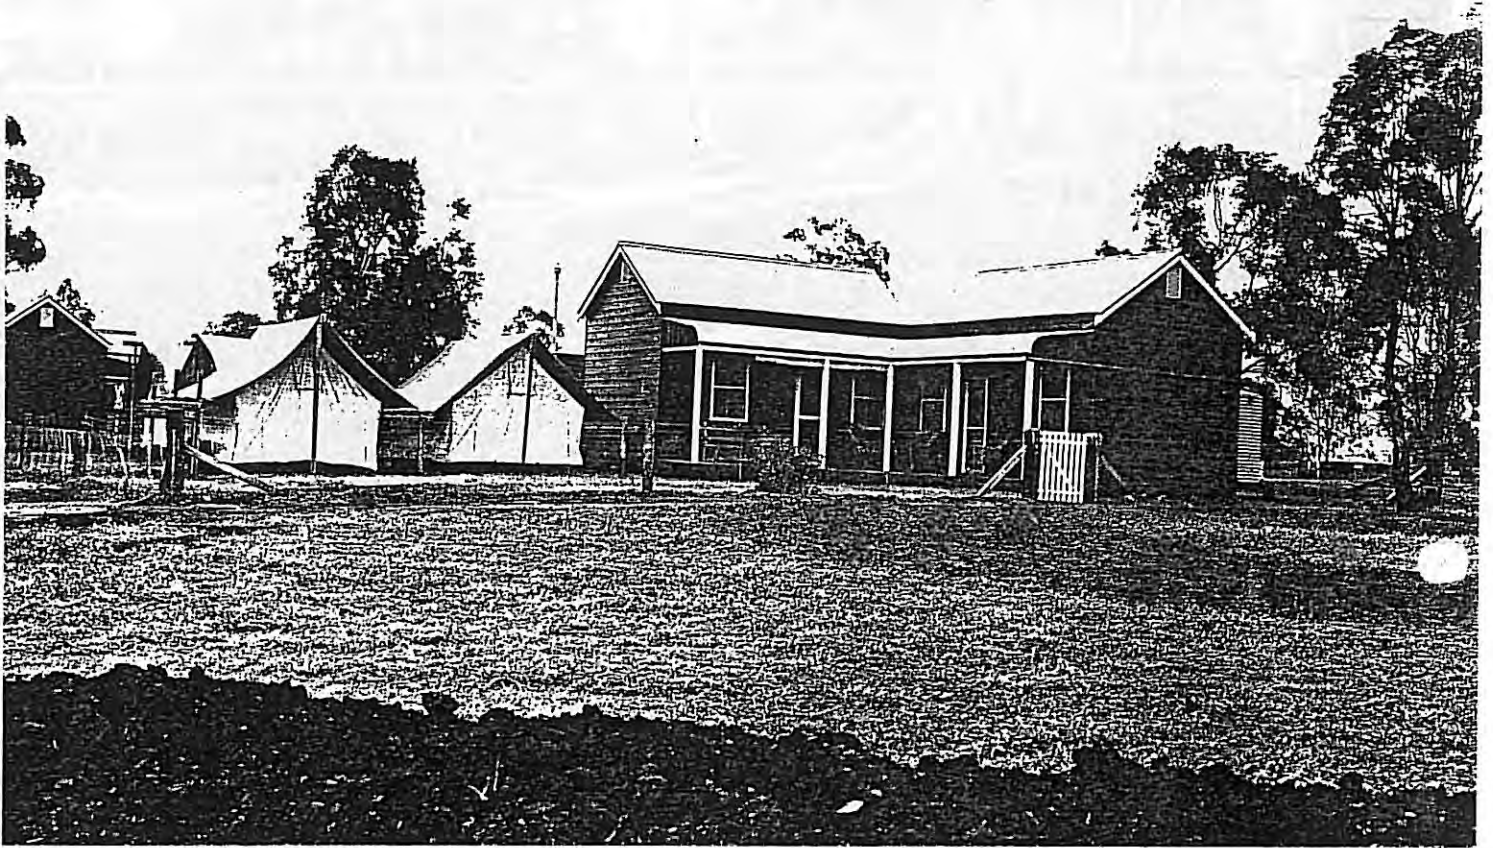
Figure 16a
Workers cottages and tents, Acton, c 1914
Source:
NLA Canberra, F W Robinson Collection,
MS5859

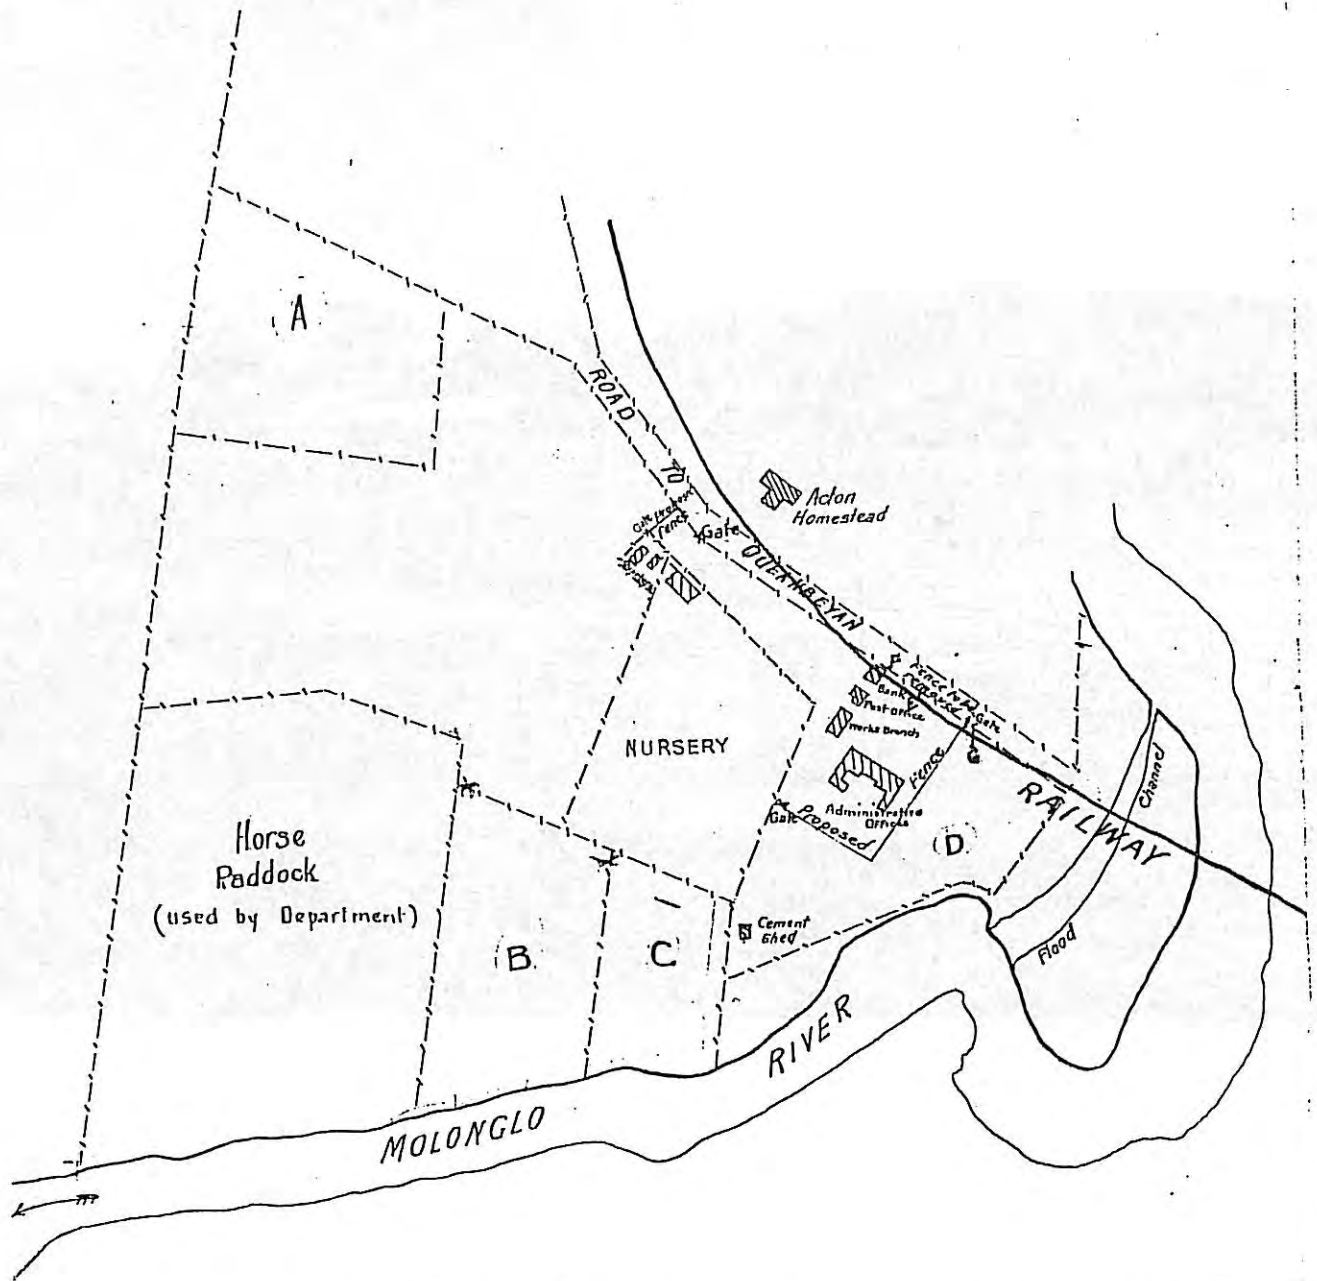
Sketch to accompany Mr. Brackenreg's report

Fencing proposed in report of 12th June 1914 shown in red

Figure 17
Brackenreg's 1914 fence survey of Acton showing proposed fence to Administrative Offices.
Source:
Australian Archives AG 18/1417

Note the location of the proposed Railway, and the 'Road to Queanbeyan'

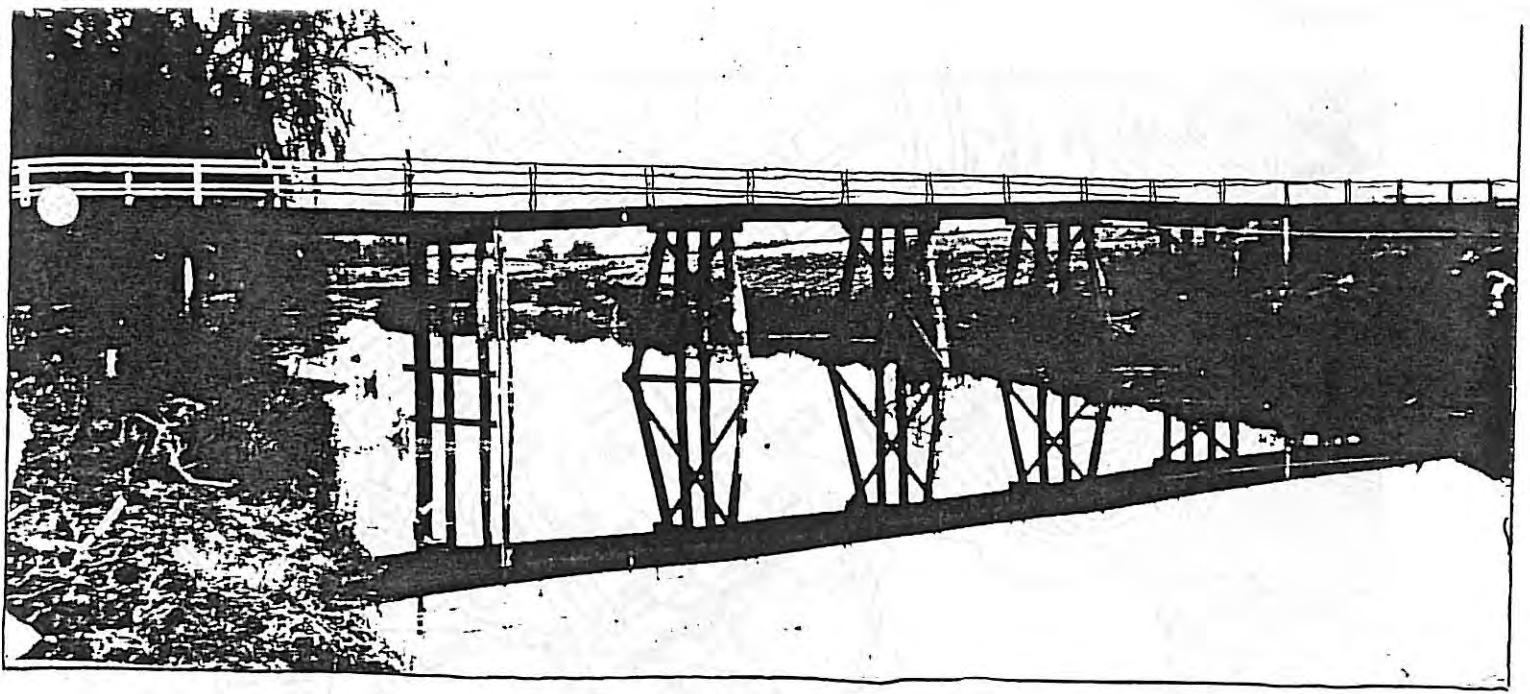
Figure 18
The first Commonwealth Avenue bridge over the Molonglo River, completed 1916.

Note that the bridge was a six span timber beam bridge on driven timber piles, built well below the flood level and inadequately designed to withstand submergence. The bridge survived until 1922 when it was damaged in the July flood.

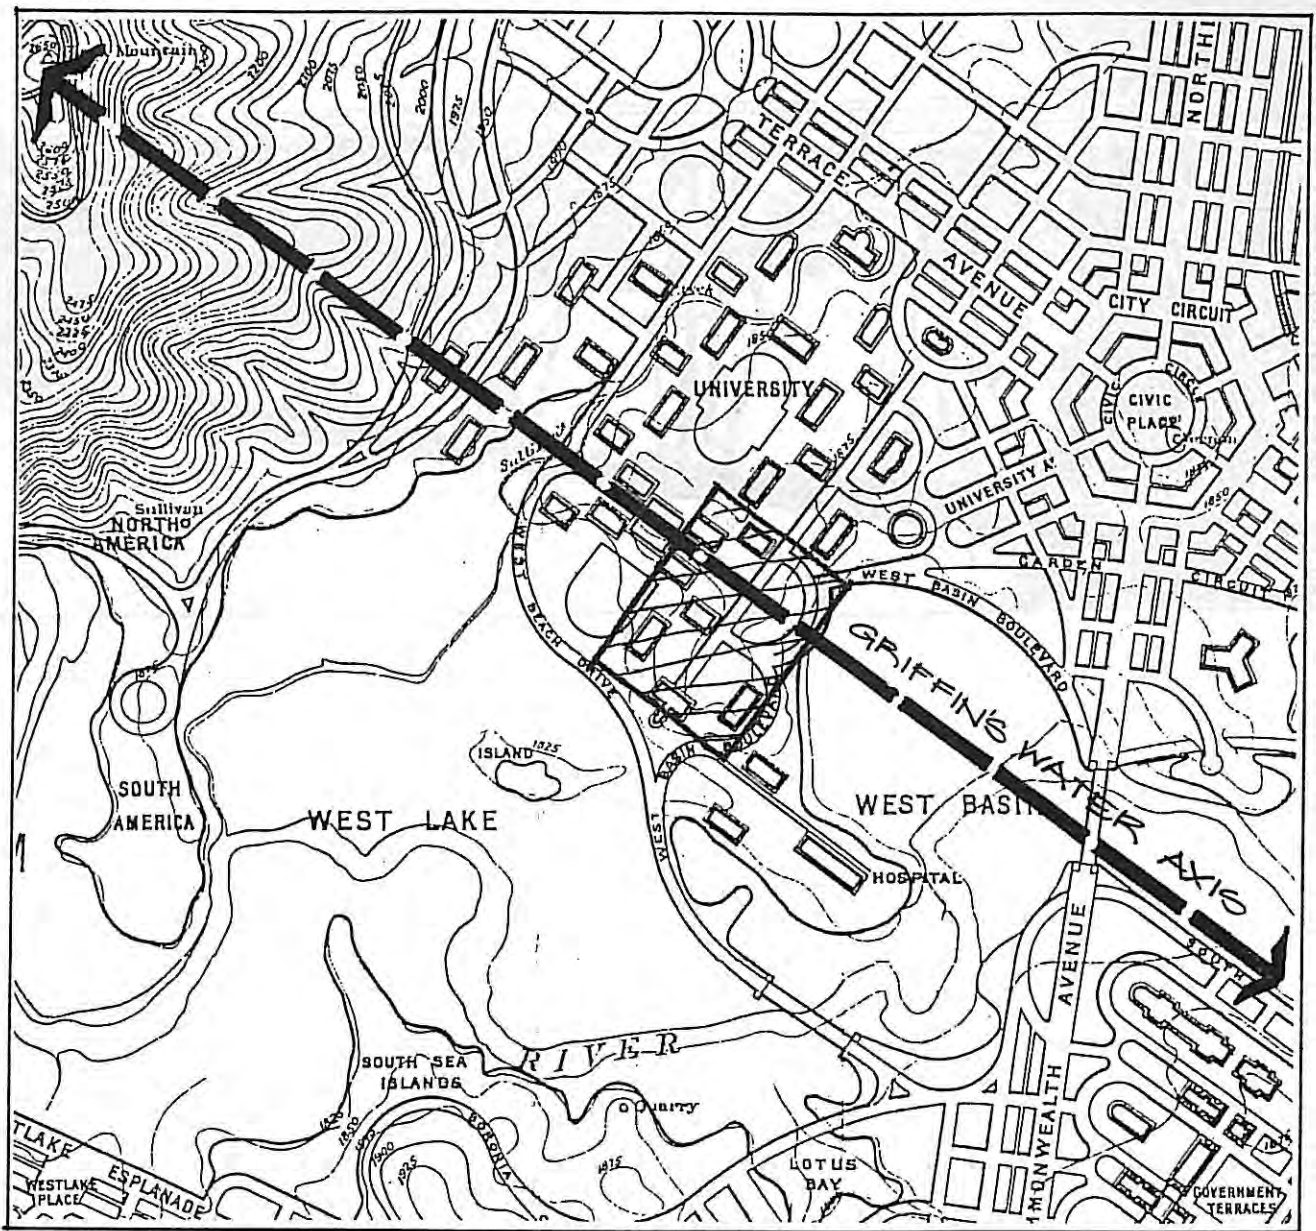
Figure 19

Griffin's proposed city plan, 1918, with Griffin's proposed water axis shown superimposed.

Note that the Griffin plan sited a hospital at the end of the peninsula overlooking Griffin's proposed lake. WBG also proposed a 'West Boulevard' crossing the new Lake Basins, thus linking the peninsula to the South.

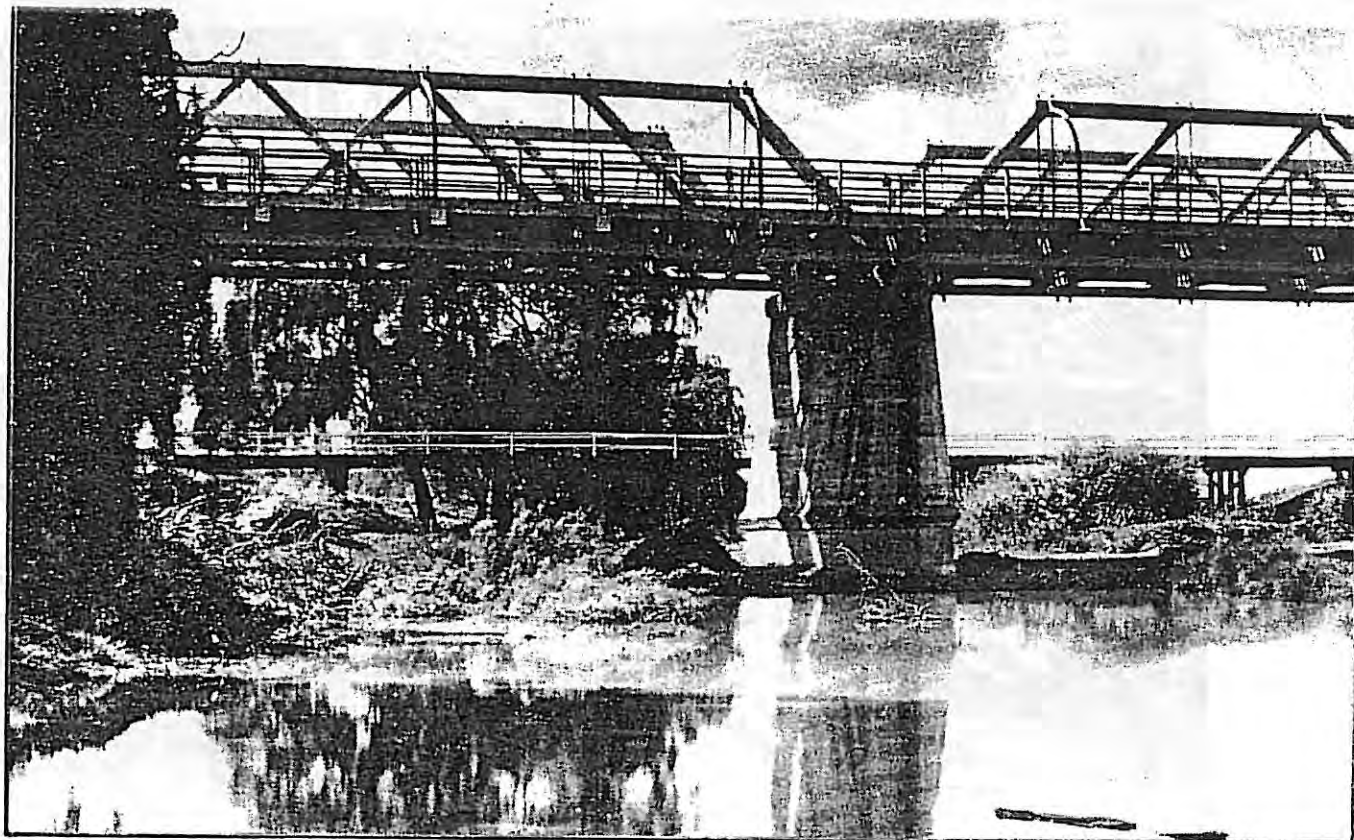
Top
Figure 3
The second Commonwealth Avenue Bridge
following its construction, 1924.
Source:
Department of Territories

Note that the first (1916) Bridge can be seen in
the background.

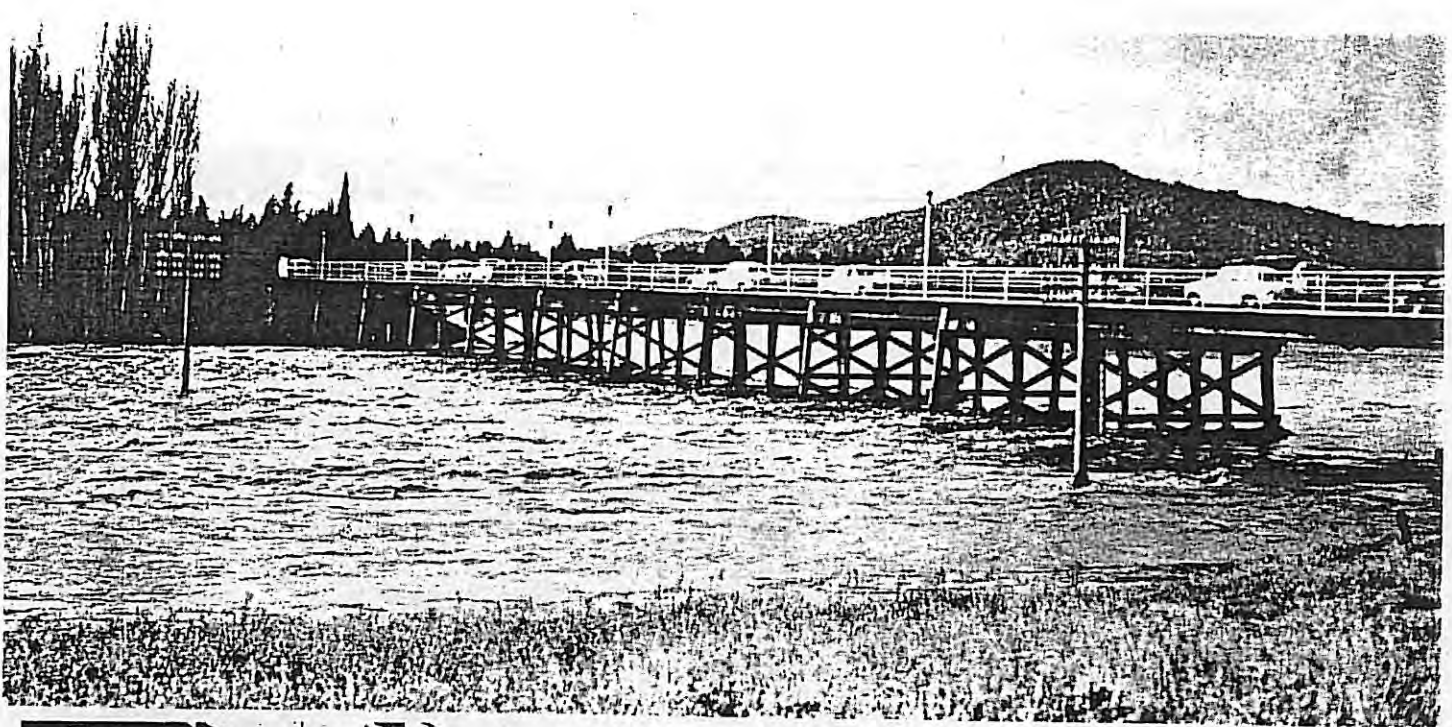
Top
 Figure 7
 The 1923 Billabong Bridge over the Molonglo River, 1956 flood.
 Source:
 Australian Information Service

The Billabong Bridge was built in 1923 following the 1922 flood. It was located south of the Commonwealth Avenue Bridges (Nos 1, 2 & 3), and used materials from the proposed King's Avenue Bridge.
 Source:
Canberra's Engineering Heritage, 1983

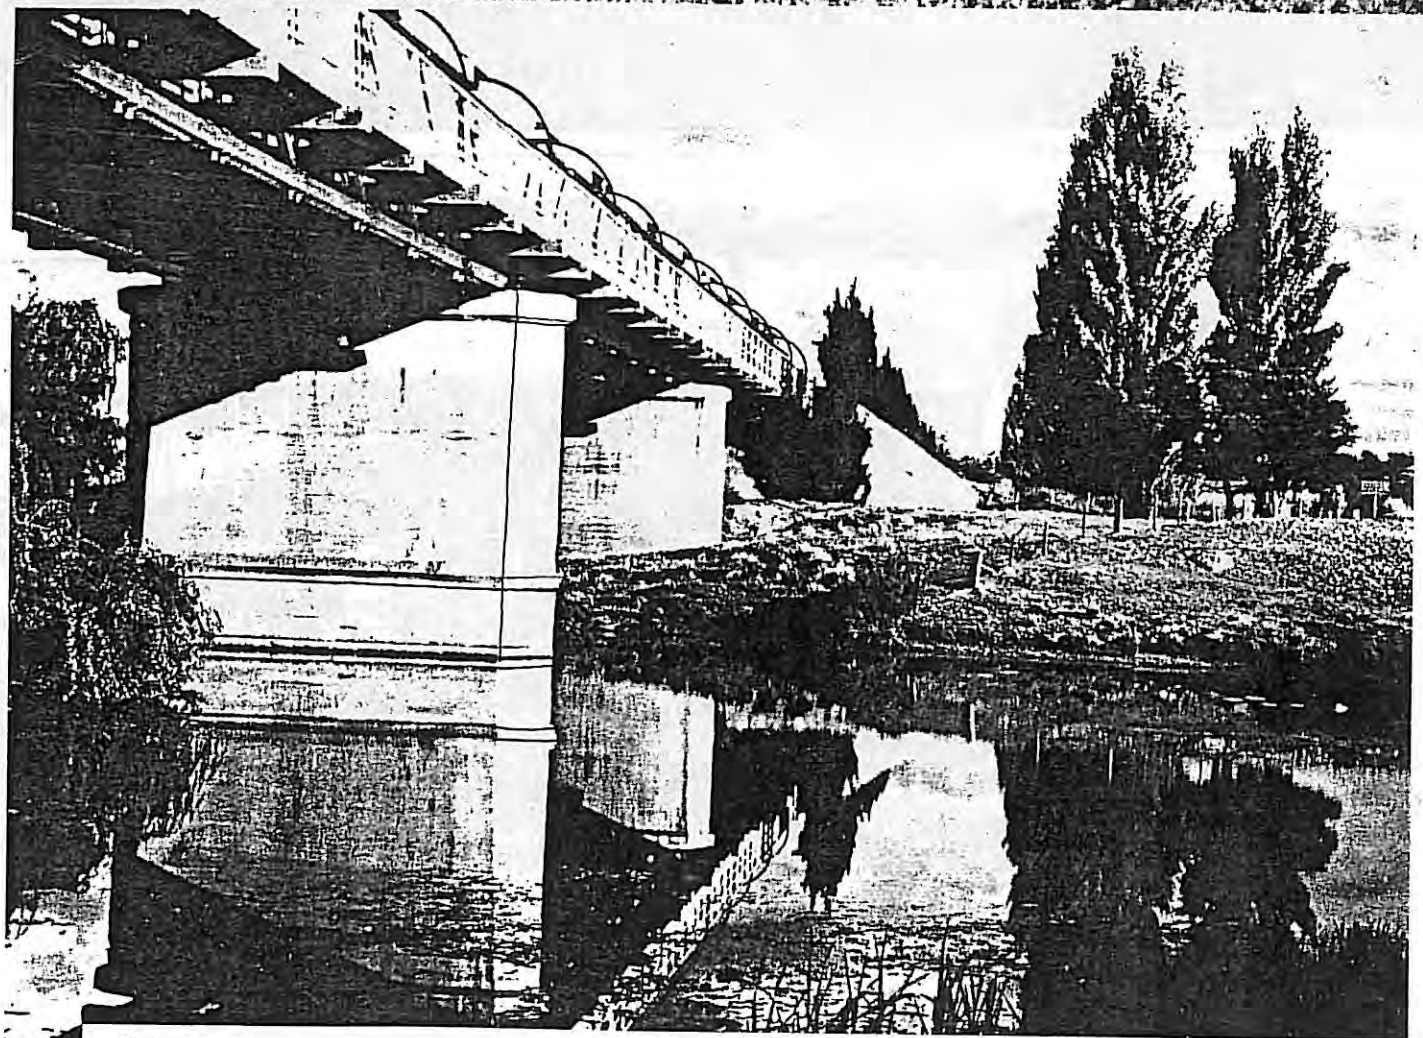
Bottom
 Figure 8
 The (third) Commonwealth Avenue Bridge, c 1927.
 Source:
 NLA Canberra, Strangman Collection

Note that this Bridge was the strengthened second bridge following the record 1925 floods. 'A phenomenal flood occurred on the Molonglo River, the water rising from practically normal to a maximum in 12 hours' Butters 1925
 Source:
Canberra's Engineering Heritage, 1983

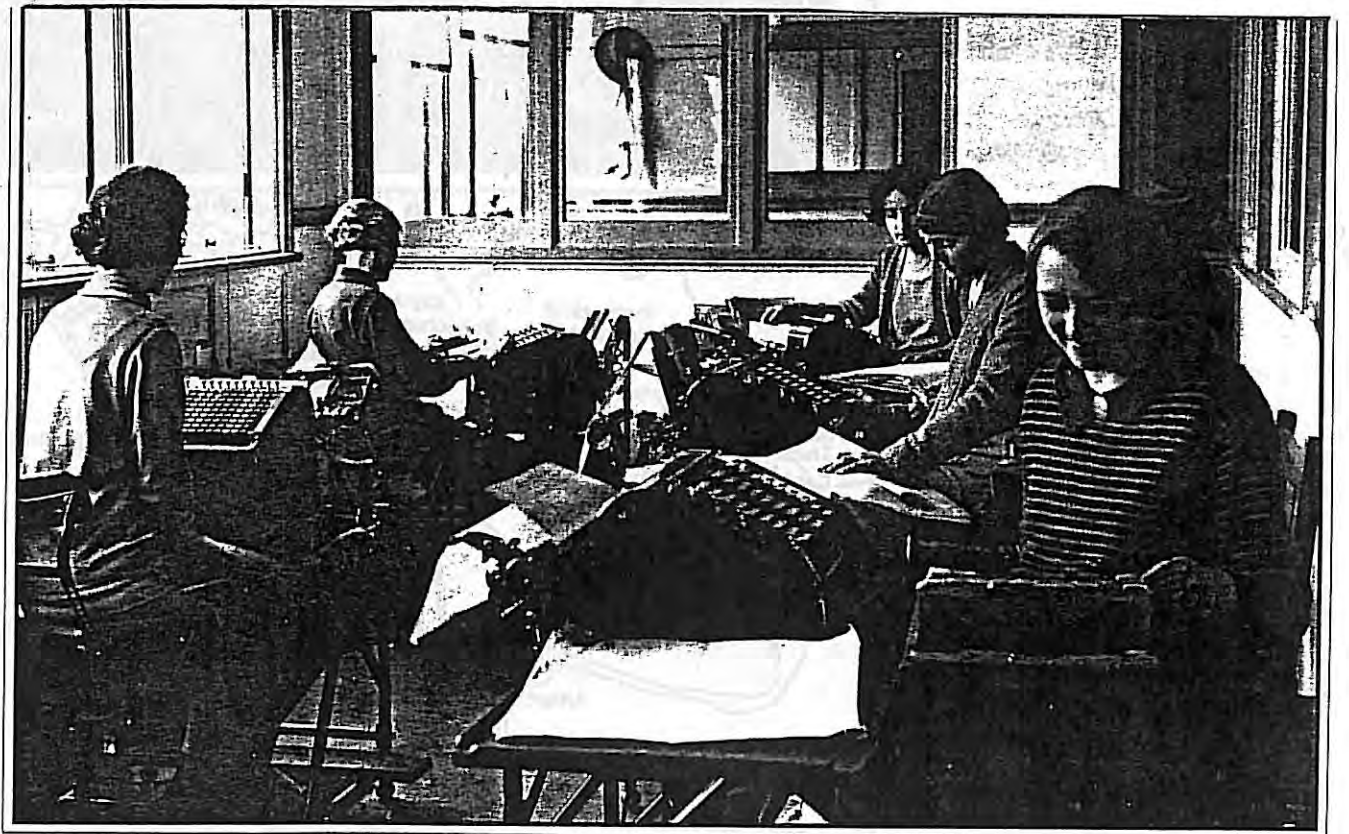
Top
Figure 14
Acton Offices, c 1926.
Source:
NLA Canberra, Mildenhall Collection

Note that the Offices were originally constructed for the Department of Home Affairs and were occupied in 1925 by the Federal Capital Commission

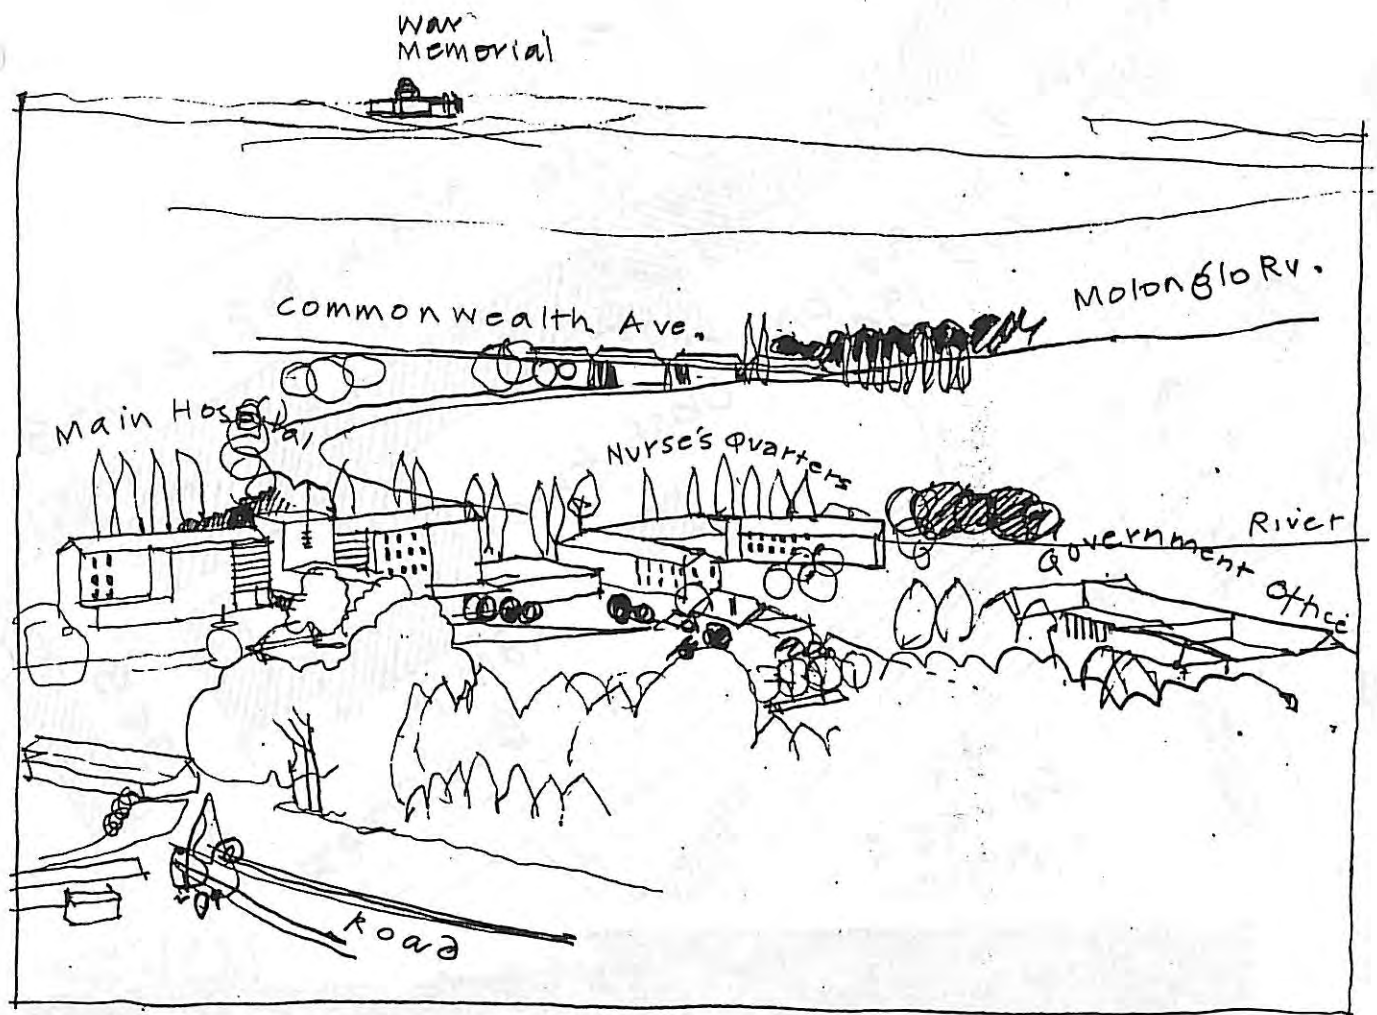
Figure 1
Aerial view of the Hospital (line drawing
overlay to photograph) c 1949
Source:
From Newman & Warren, *Royal Canberra
Hospital*, 1993
