4 CULTURAL FEATURES OF THE ACTON CONSERVATION AREA

The Acton Conservation Area consists of four main site complexes: Lennox House zone, Old Canberra House zone, Acton Cottages zone and the Old Canberra Community Hospital zone. The zones are illustrated in Figure 4.1.

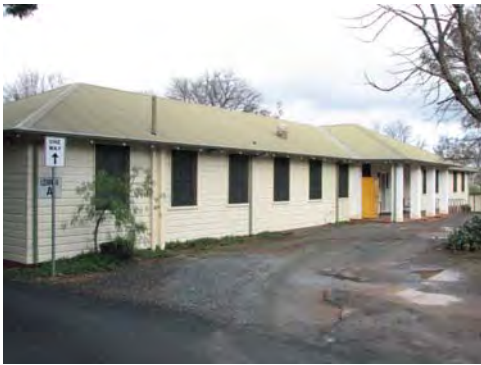
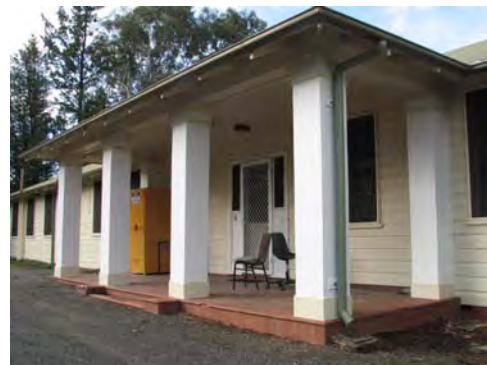
A Block (view SE), 2009

Front portico of A Block

A Block is generally in good condition, with a high degree of original fabrics, though have been painted over in most cases. Internal linings require some basic repairs, as do the windows and doors.

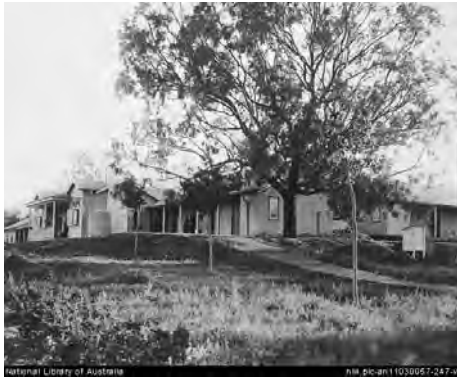
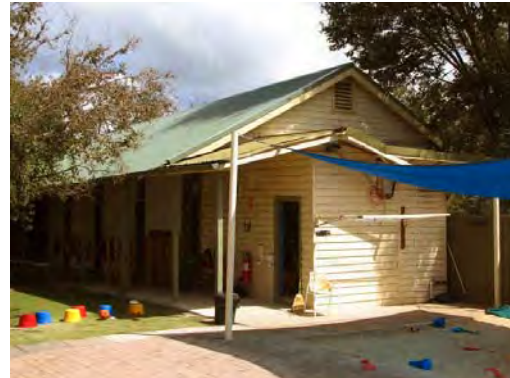
View southwest of D Block (nla.pic-an11030057-247)

Modern view southwest of D Block (Armes 2007)

An important feature of the building is the remnant carpentry and roofing which belonged to the covered link proceeding uphill to B, C and A Blocks. Apart from some other much more ephemeral signs, this is the only surviving evidence of the covered links between buildings (Figure 4.7).

D Block is in good condition. Much of the original fabric remains. The most noticeable alterations are the concrete floor of the verandah and the replaced verandah posts. Some repair work was undertaken on the building in 1998, including new floorboards and parts of walls.

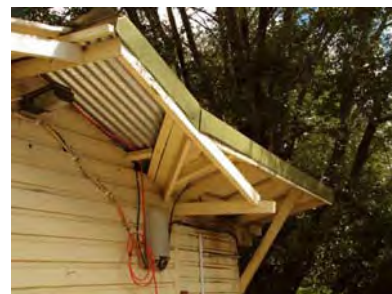
Figure 4.7: Remnants of the covered walkway between buildings (Armes 2007).

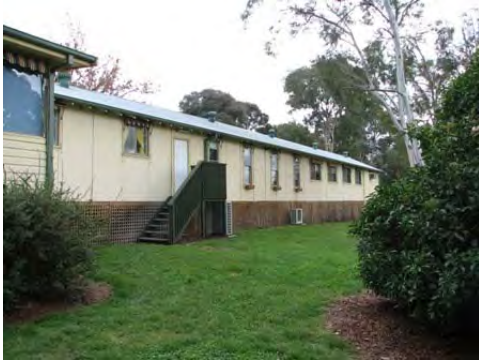
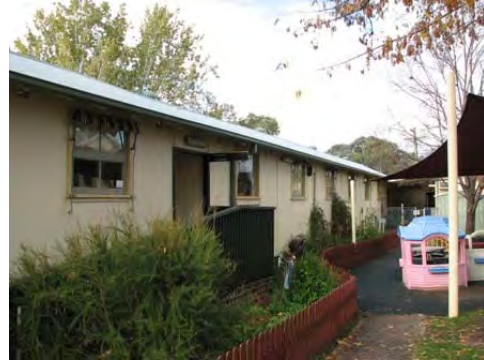
West side of E Block, 2010

East side of E Block

E Block is an elongated timber-frame building with fibro walls. It represents a departure from the standard rusticated weatherboards seen in the other buildings of the Bachelors Quarters, though retains the corrugated iron roof. The addition of this structure at Lennox House signalled the loss of symmetrical planning and the obstruction of the main façade of F Block.

E Block has survived the rigours of total relocation and heavy internal alterations for use as child-care. The fabric is in reasonable condition, but displays cycles of alterations. The building is poorly insulated and has settled to show distortions in some places. The presence of asbestos sheeting will require further investigation.

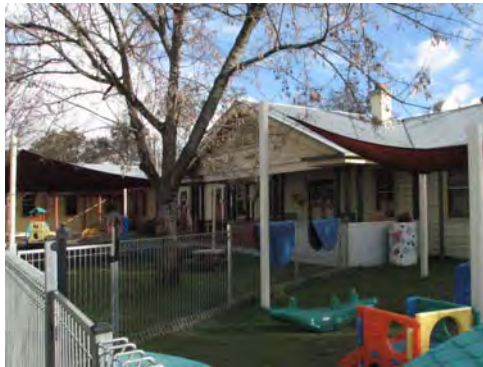
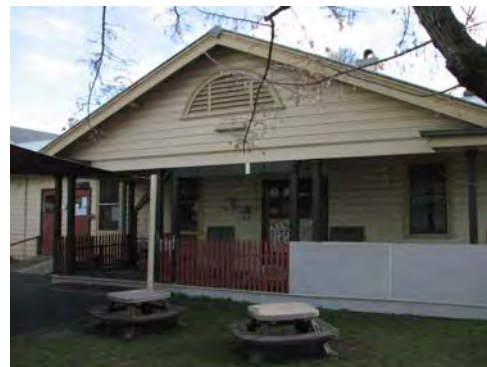
Courtyard between E and F Blocks, 2009

The original front façade of F Block, 2009

The exterior of the building is mostly intact. Modern alterations include entry doors in some places and a new balustrade to the eastern portico. The roofing was replaced in about 2000. The interior has much of the original material still in use, although several layers of paint have been added. Many internal walls have been removed, but evidence of early wall locations is still clear through nib walls and bulk-heads. The building remains in sound, serviceable condition.

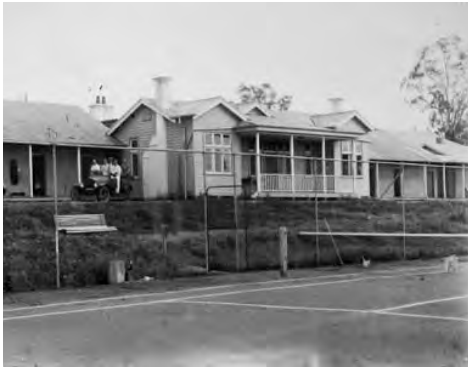
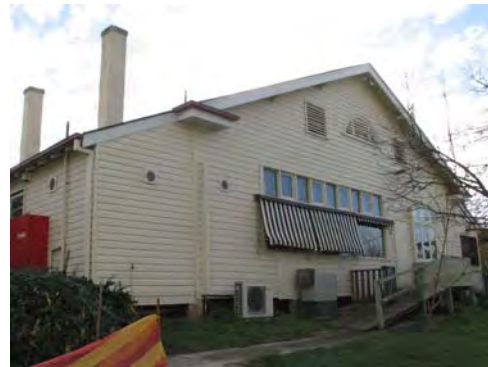
View NW of G Block, 1926 (NAA A3560, 200)

View NW of G Block, 2009

The building is generally sound. The exterior has been altered with a variety of aluminium windows, modern flush doors and the enclosure of original verandahs. The building is sited well above the ground and the sub-floor frame appears sound. Parts of the roofing and some of the weatherboarding require basic repairs. The interior has been altered with improvised partitions and the installation of fittings and fixtures required for compliance and licensing reasons.

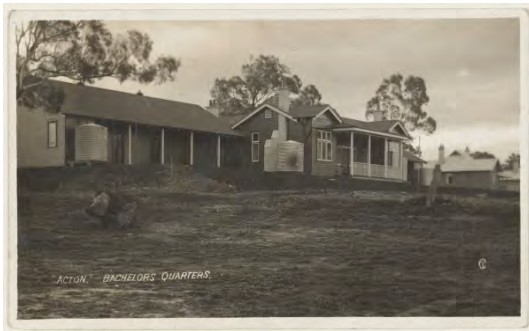
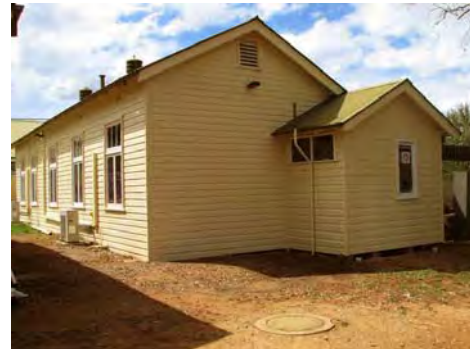
H Block (centre left), 1926 (NAA A3560, 200)

Southern end of H Block (Armes 2007)

The building remains in good condition after refurbishments in 1998. An accumulation of dirt at the western wall should be removed to provide sub-floor ventilation.

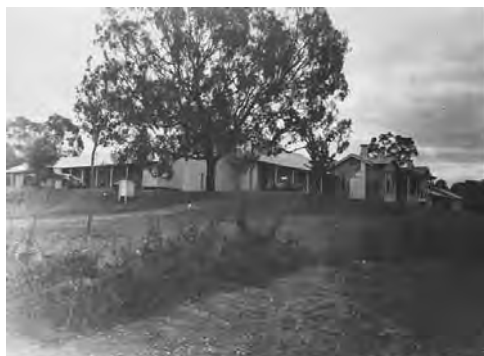
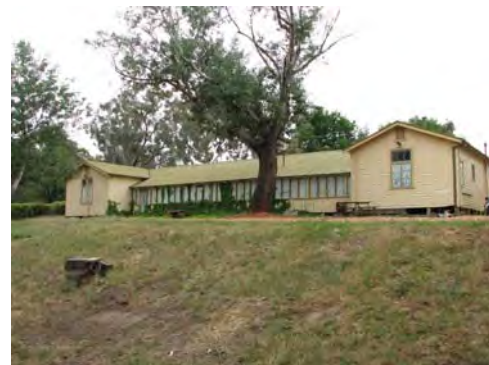
I Block of the Acton Guest House
(nla.pic-an11030057-2539)

Northwest view of I Block, 2009

I Block has had several alterations to entry doors and windows and the southern verandah has been enclosed with louvers and fibro. The verandah floor is in poor condition. The building is generally sound, although there is some damage by white ants. The interior of the original Warden's Flat is mostly intact and the other rooms are sufficiently intact as to clearly demonstrate the construction of the building. Downpipes are not connected to effective drains and the roof requires repairs.

The building is today maintained only to prevent unauthorised access. Much of the fabric is sound, but begs repair and conservation.

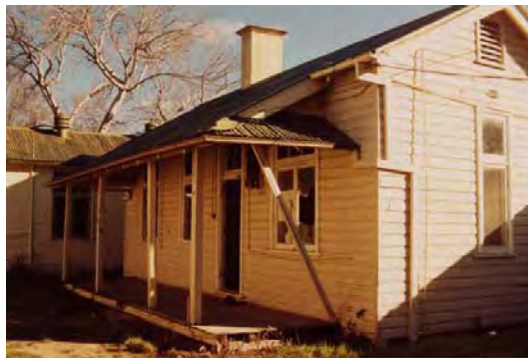
J Block prior to demolition (Armes 1996)

J Block was constructed of a timber-frame clad in weatherboards on concrete foundation piers. Drawings of 1925 designate the building as Servants' Quarters, while an undated sketch shows J Block as a Manager's Residence. A Department of Works sketch shows the building to be store rooms and also shows Laundry A at the northern side. A 1969 drawing shows the building used as a Tutor's Room and Warden's Office.

The building was seriously damaged by fire and demolished in 1998 after a review of its condition concluded that there was no prudent and cost-effective potential for adaptive re-use. A measured drawing of the building was prepared for archival purposes.

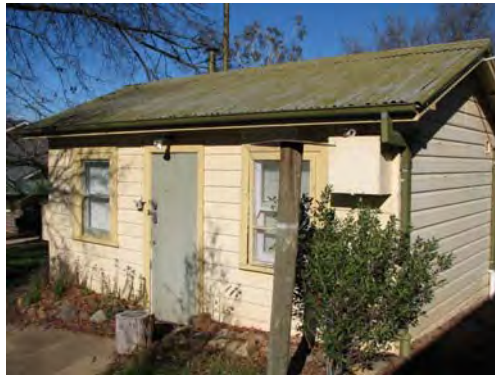
Laundry A, 2009

This small building is a well-crafted timber-frame structure lined with rusticated weatherboards. It has a single room with a concrete floor and walls lined with fibro and timber cover strips.

The building is in sound condition, although the south-east corner of the floor slab requires attention.

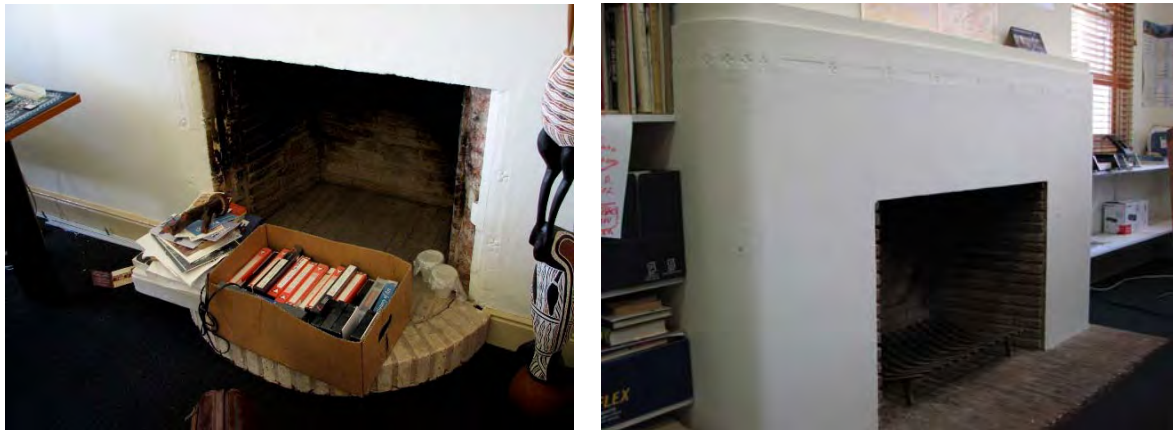
Figure 4.21: 'Original' features of Old Canberra House include a number of fireplaces, joinery and some art deco wall vents.

The panelling in the foyer has seen some restoration, although is largely reminiscent of the original form, as observed on the early plans of the building. The decorative joinery around the foyer fireplace combine with the dressed and exposed ceiling joists to provide a British character to the room. The fireplace is constructed of bullnose face bricks, with a generous timber (English Oak?) surround and tapered square pillars with a slight entasis (similar to 16 Lennox Crossing), a marble hearth kerb and ceramic tiles to finish. The ceiling panels between the joists are trimmed with an ovolo bead.

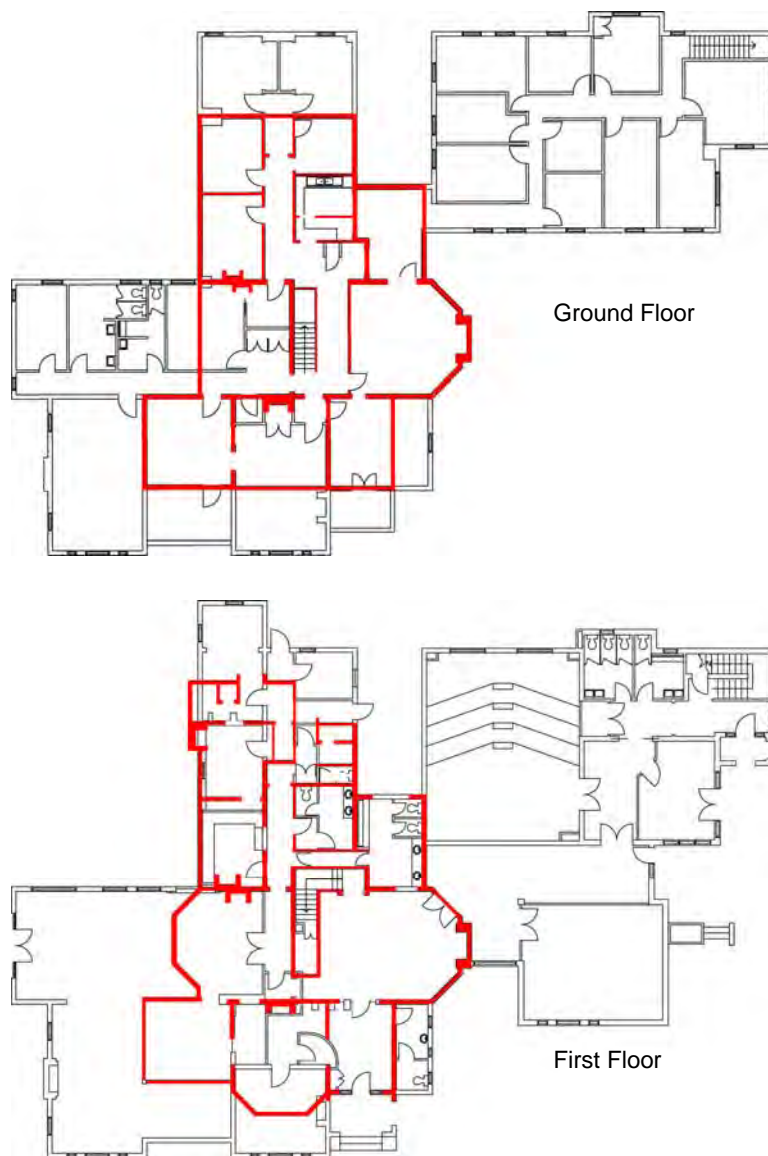
Figure 4.22: The growth of Old Canberra House (red frame illustrates original layout)

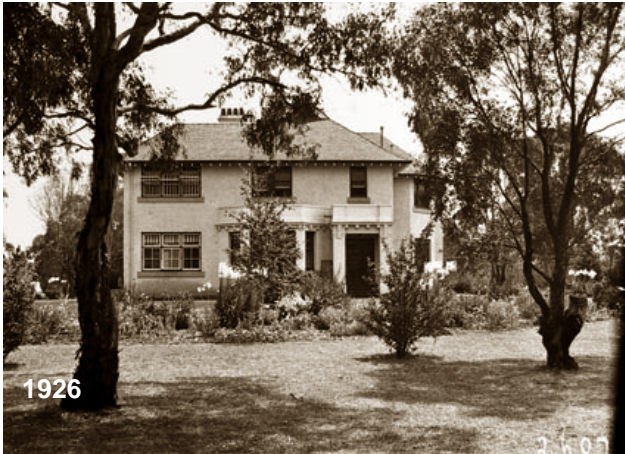
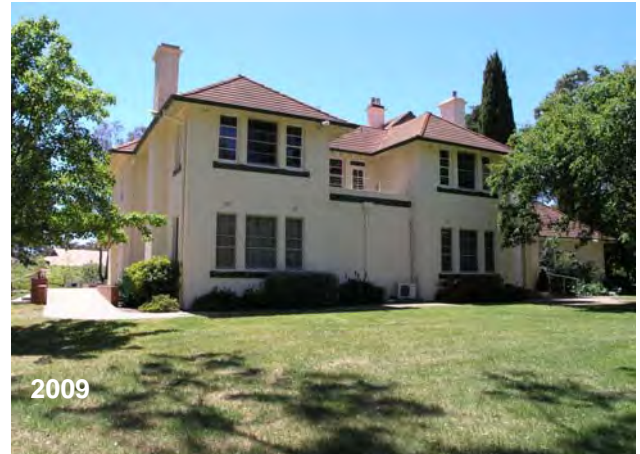
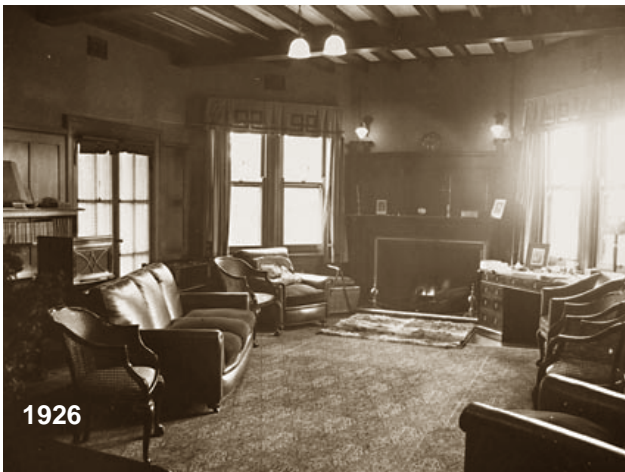
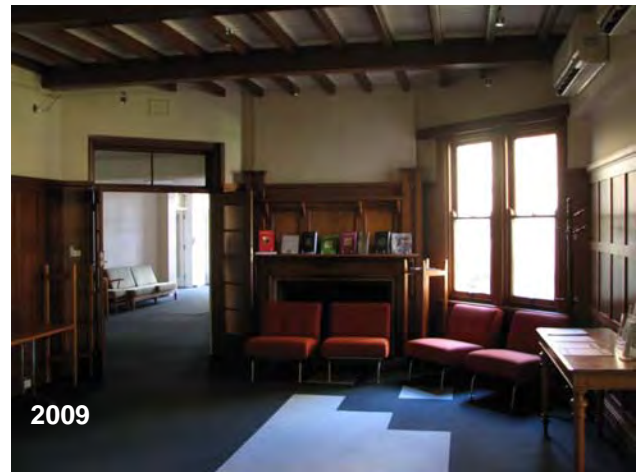
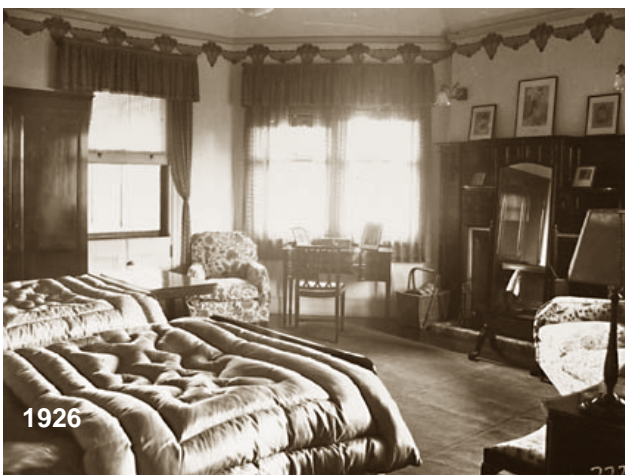
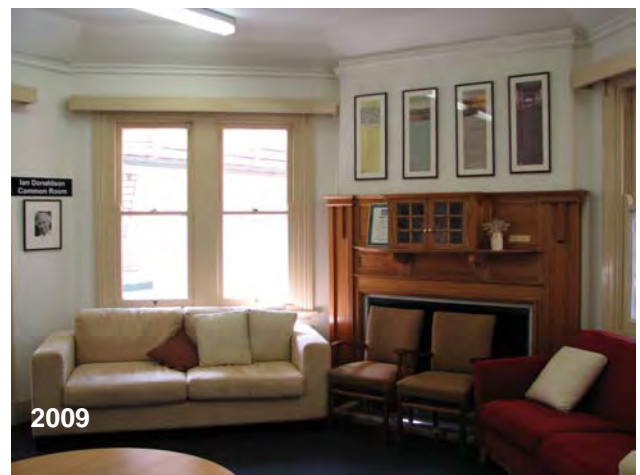
A large crack has appeared in the wall outside the Director's Office (first floor northern corridor), as well as some paint flaking in the Common Room. Previous water leaks in the Conference Room have left unsightly staining to the ceiling panels.

Figure 4.23: Though much of the original Residence has been lost, the foyer (centre right) and upstairs Common Room (lower right) are strongly reminiscent of the original form. Joinery and fireplaces are notable parts of the building (NAA A3560, 7567/7569).

Overall, Old Canberra House is in good condition. The fireplaces require some repairs, including a new marble kerb in the foyer. The roof tiles show some signs of age, with isolated instances of cracking and the external façade requires some basic repairs and paintwork to the roughcast. Water has stained the ceiling in the Tea Room and Conference Room.

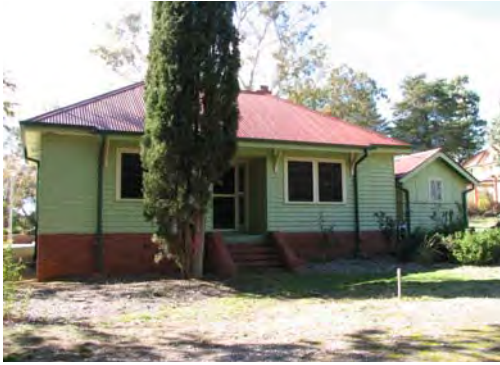
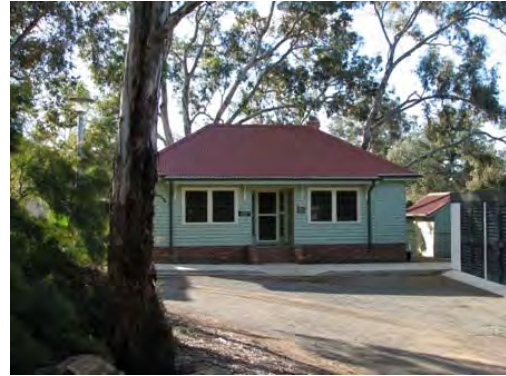
Chauffeur's Cottage (prior to transfer),
view east (front)

Chauffeur's Cottage in new location,
view north (front)

The chauffeur's cottage has recently been transferred to the east of the gardener's cottage in line with the construction of the Crawford School. It is in good condition following the recent refurbishments and survived the move intact. Original 'Canberra' red bricks were salvaged from other sites in the city and used in the reconstruction of the base and the addition of a small set of stairs at the rear.

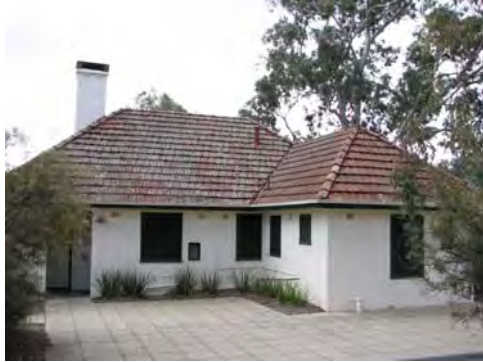
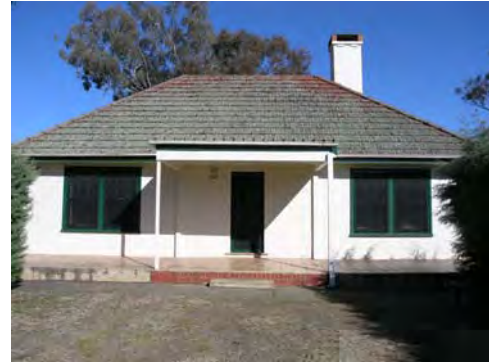
Gardener's cottage, view north (front)

Gardener's cottage, view south (rear)

modern additions observed throughout (climate control systems, door locks and kitchen and bathroom fixtures). The roughcast finish has minor signs of wear, though the building is generally in good condition.

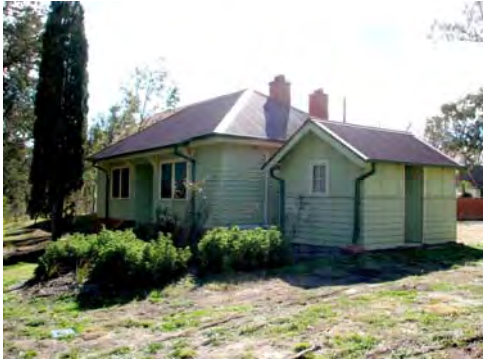
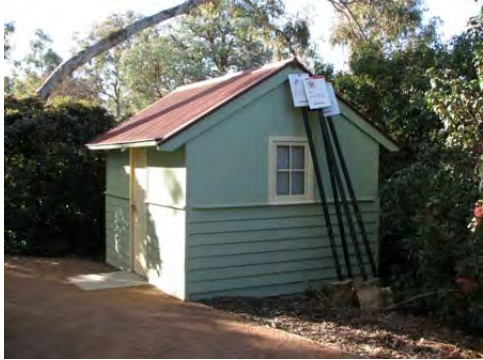
<p data-bbox="272 853 715 913">Garden shed (to south of Chauffeur's cottage prior to transfer), 2009</p>

<p data-bbox="868 853 1257 882">Garden shed after transfer, 2010</p>

The building has recently been transferred to the east of the gardener's cottage, along with the chauffeur's cottage. It is in good condition.

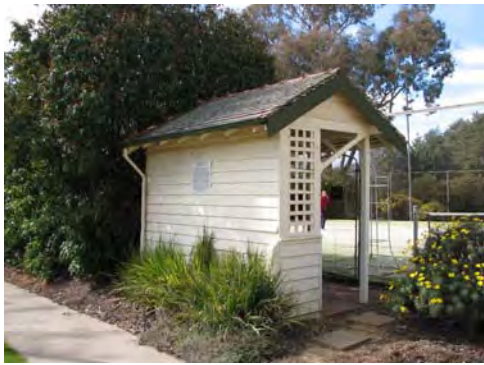
Tennis court shed, view northeast, 2009

The tennis court is in good, playable condition and has been well-maintained. The court shed is also in good condition, although there is some rotting to the timbers on the lower north corner.

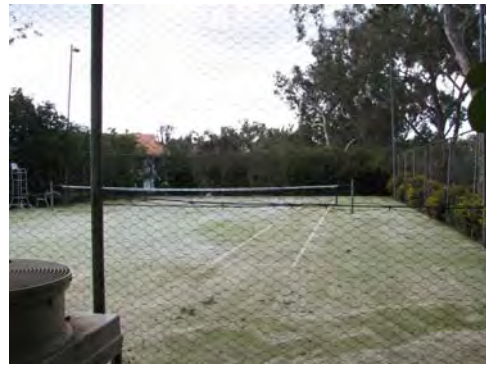
Tennis court, view north from Canberra House, 2009

The tennis court shed is a small shelter with rounded weatherboard cladding to the rear (west) and flanked on the north and south with lattice screens. The roof is formed of small terracotta tiles (likely original) and bordered by eave overhangs to the east and west. The walls have been painted white and the eaves stained dark green.

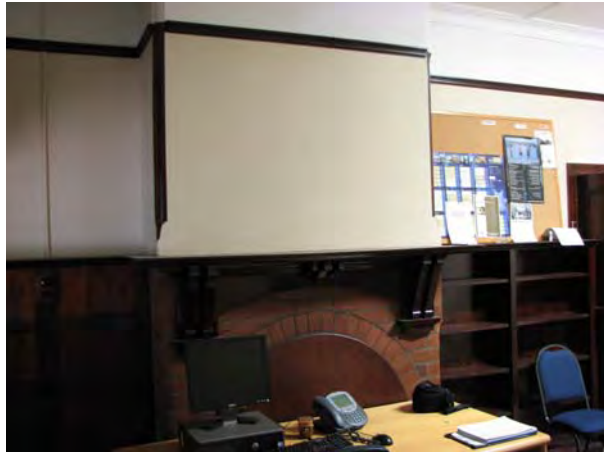
Figure 4.28: The living room fireplace is intact, though no longer used.

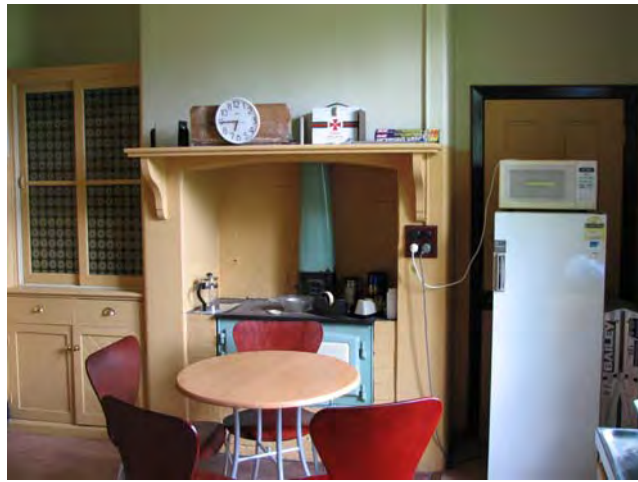
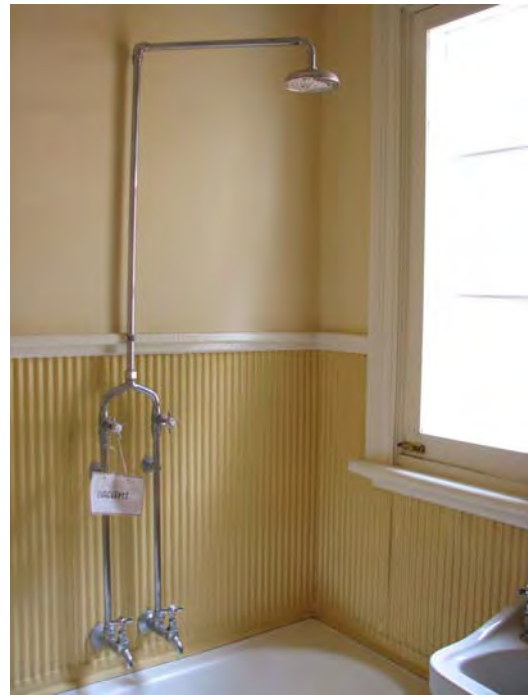
Figure 4.29: Intact features of the kitchen and bathroom

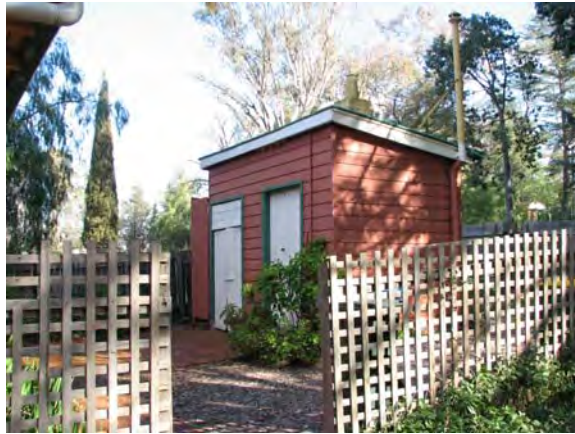
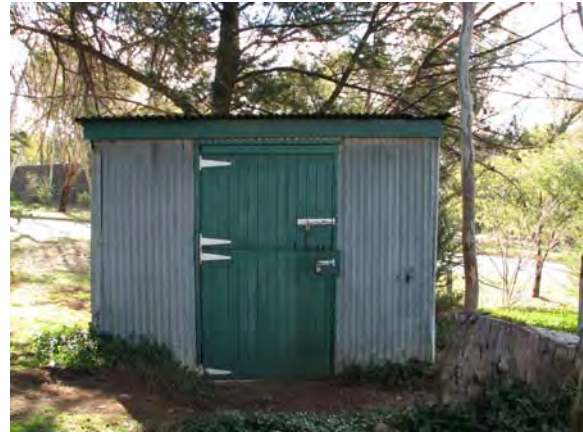
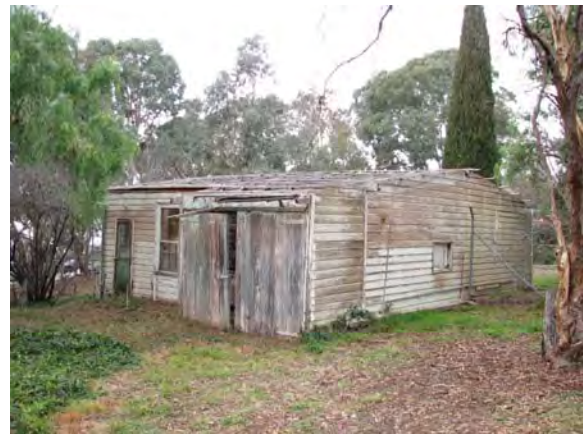
Figure 4.30: The intact laundry and loose-box buildings, and dilapidated stables/garage at 16 Lennox Crossing, 2009.

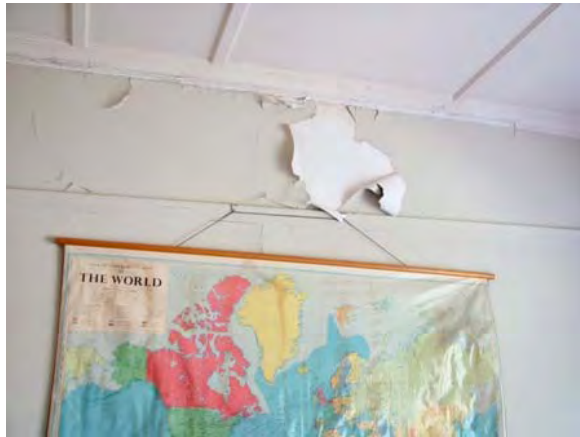
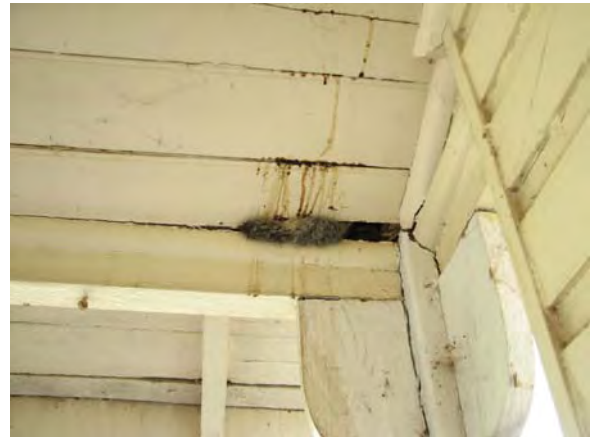
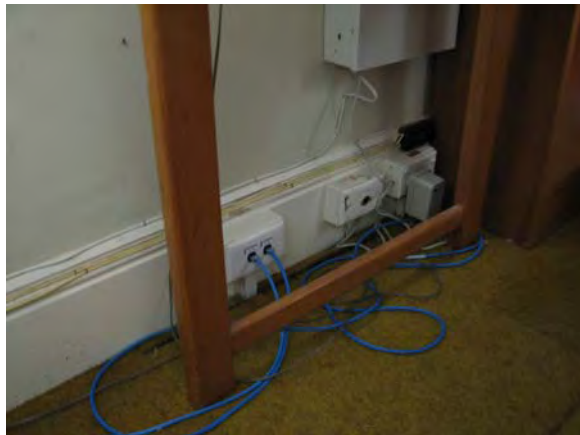
sustained some scuffing and chipping. The kitchenette (room located immediately northwest of the original kitchen) has modern fixtures and requires basic repairs to the floor, walls, cupboards, sink and ceiling. There is evidence of rotting in the west wall of the bathroom. The southwest wall of the bathroom has been damaged by possums, with some staining.

Figure 4.34: Damages and poor installation of services in the cottage at 7 Liversidge Street.

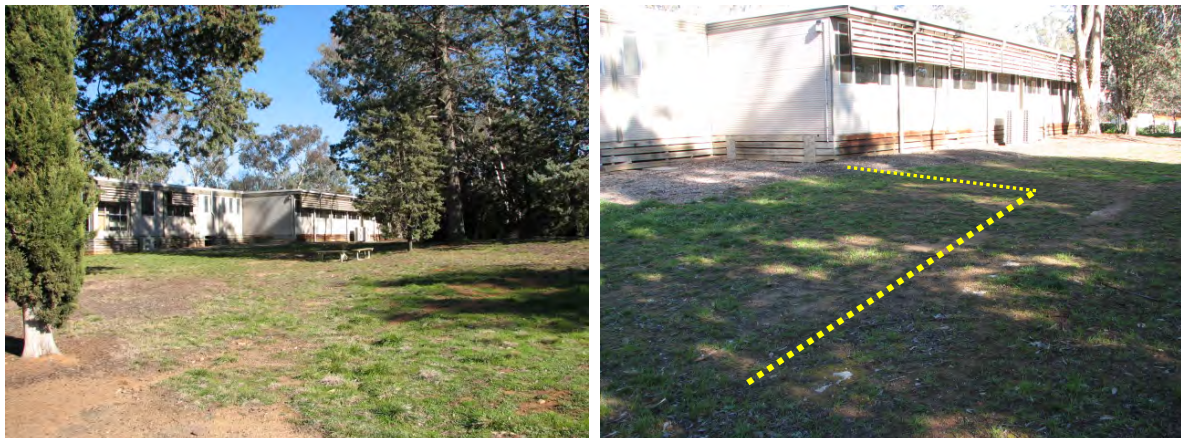
Ephemeral evidence of the cottage foundations remain in-situ, though the site's suitability for archaeological investigation remains to be seen (some small pieces of brick and ceramic shards were observed). Part of the foundations have been obscured by the modern demountable building to the south.

Figure 4.35: View southwest of the site of 9 Liversidge Street, 2009. The modern transportable building can be seen to the south, encroaching on the remains of the cottage foundations (dashed line indicates foundations).

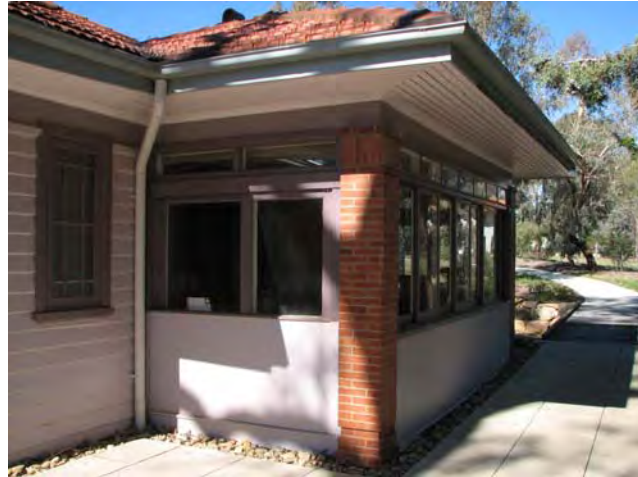
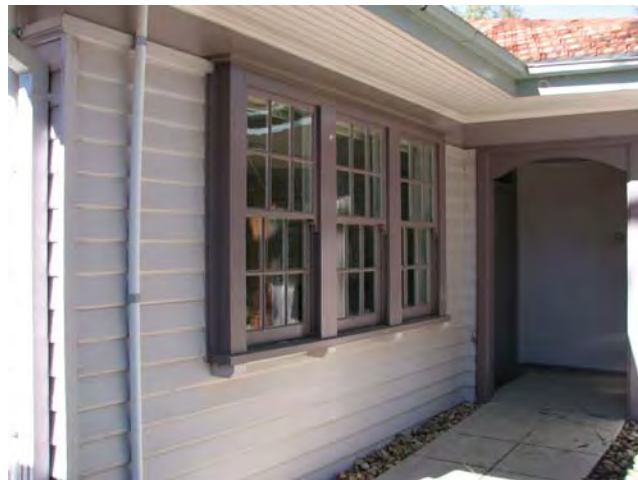
Figure 4.36: Two important features of the western façade are the enclosed verandah (above) and late Federation period 'triple' window (below).

The windows are double hung with six-pane sashes and ogee horns. The verandah is enclosed with single pane sashes. The northern window of the verandah appears to be a sliding door, with the lower half consumed in a later fibro wall. The northeast sleepout has four-pane casement sashes, each pane with slender proportions. The northwest window develops the 'triple' window theme established in the late Federation period, mounting three double-hung windows in one assembly, on the outside wall frame. The assembly is seated on four dentils (Figure 4.36).

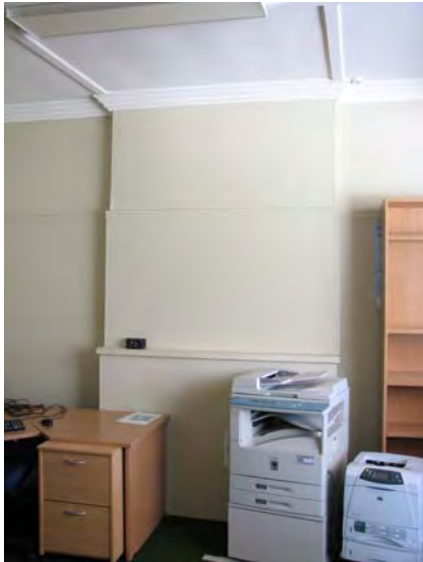
cornices and architraves. Strapped ceilings in the northwest office are more expressive than elsewhere in the building, embodying angled block mounts at the intersections. The straps in the ceiling of the central living room lead to the chimney breast. The fireplace has been boarded and painted beige, in line with the walls and has lost the imposing presence it would have originally commanded. Like most of the rooms the original kitchen has been converted into office space. The range, fittings and appliances have been removed, although the original mantle above the range has survived and is painted white. The two windows at the rear of the stove were also retained (Figure 4.37)

Figure 4.37: The fireplaces of the living room and kitchen range, 2009.

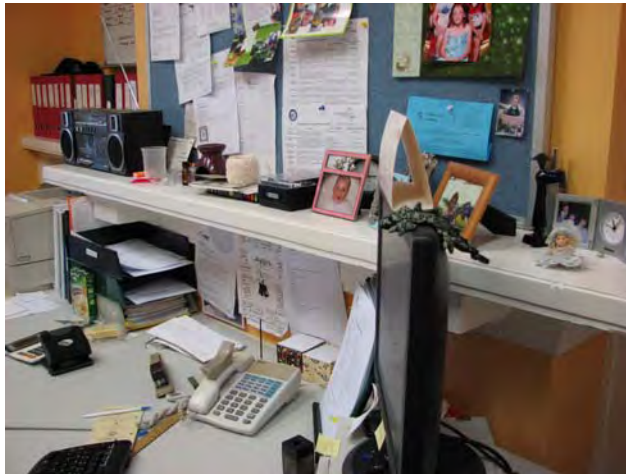
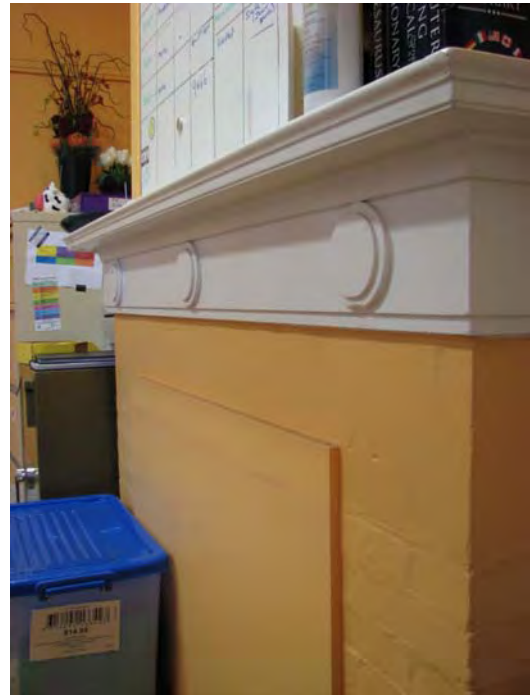
The dining room fireplace has been converted into part of a workstation, and is an interesting use of an otherwise awkward feature in such a space (Figure 4.39). The mantle has a simple beaded quirk and is painted white. The fireplace in the master bedroom (now a play area) has an ogee scotia mantle, with a number of modern hooks attached beneath.

Figure 4.39: The sitting room fireplace (above) and dining room fireplace (right).

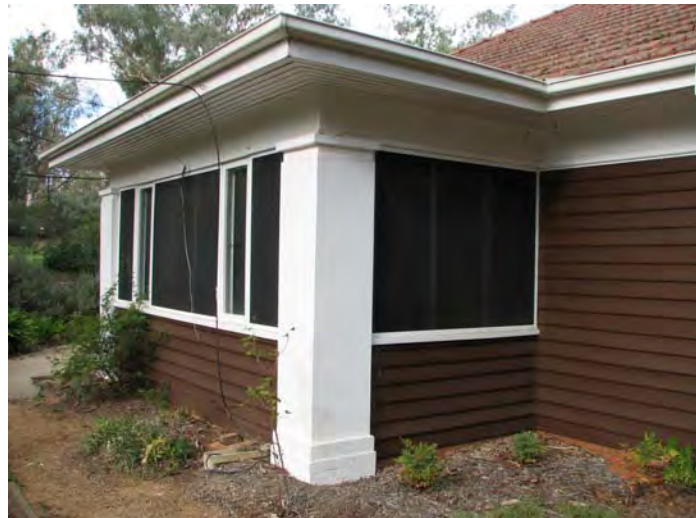
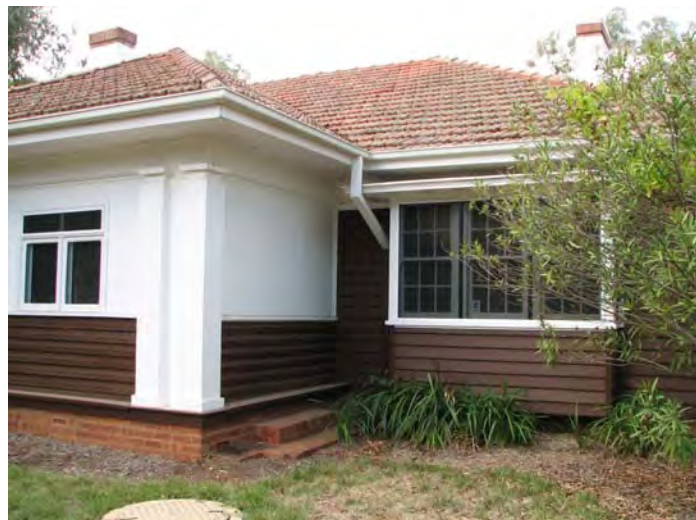
The living room and dining rooms have highly decorated fibrous plaster ceilings, with a complex pattern of panels and mouldings. There is a picture rail lining the rooms, window pelmet and a plate shelf above the bay windows, although the bay window seat has been removed in the southern office. In 1993 the dining room showcased dark varnished plywood panelling and intact cover strips; a strong feature of the room that has since been lost. The cornice is a combination of ogee and scotia. The architraves have a series of stepped flat fillets, a distinct fashion of the times. The skirtings have a similar character, but a groove has been added above the centre.

Figure 4.40: The north verandah (above) and western verandah with bay window.

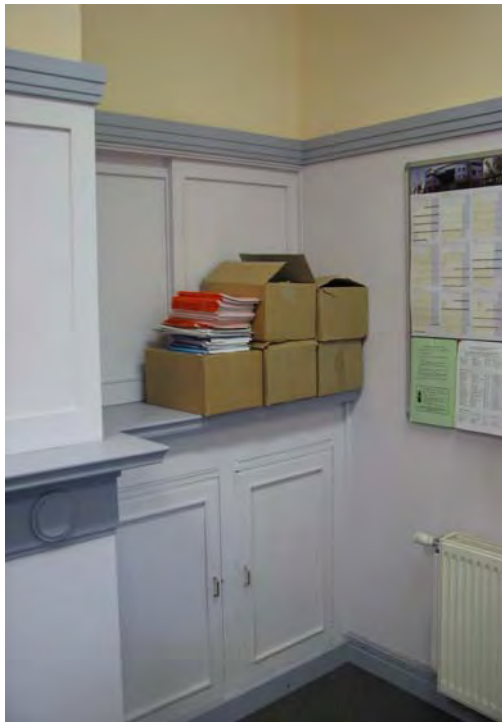
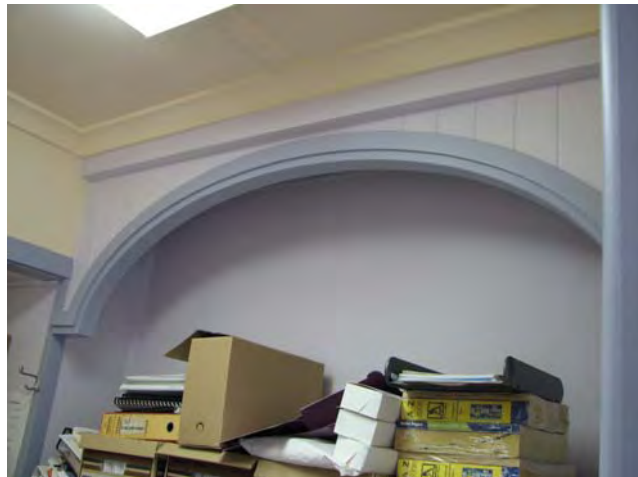
Figure 4.41: The beaded arch between the breakfast room and kitchen (above) and the original servery cupboards.

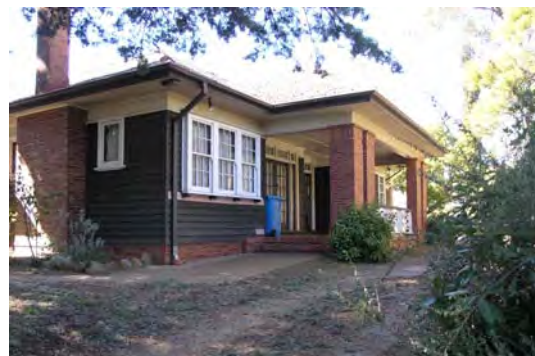
View south-east of 20 Balmain Lane, 2009

The building is in good condition, though begs restoration and repairs. There are signs of cracking in the walls (do not appear to threaten the structural integrity of the place); the whole needs to be re-stained or repainted. A number of door frames have been damaged and isolated instances of holes in the walls should be repaired. Modern additions, such as the shelving affixed to walls, electrical switches directly to skirting boards and modern lighting should be avoided.

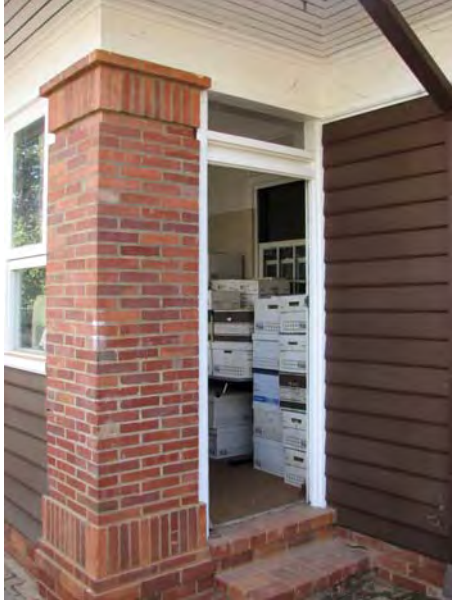
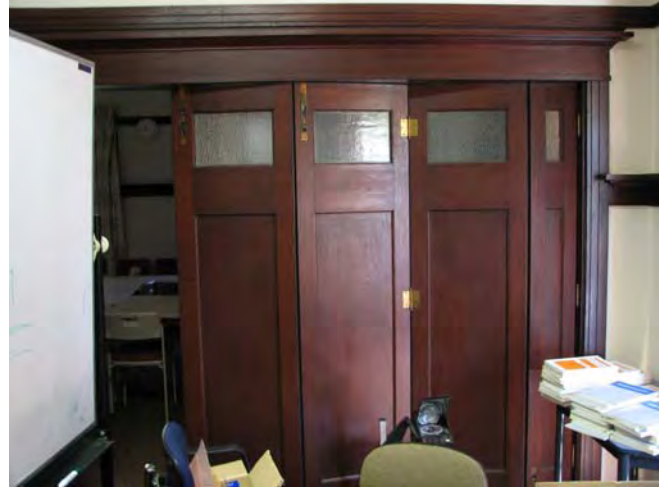
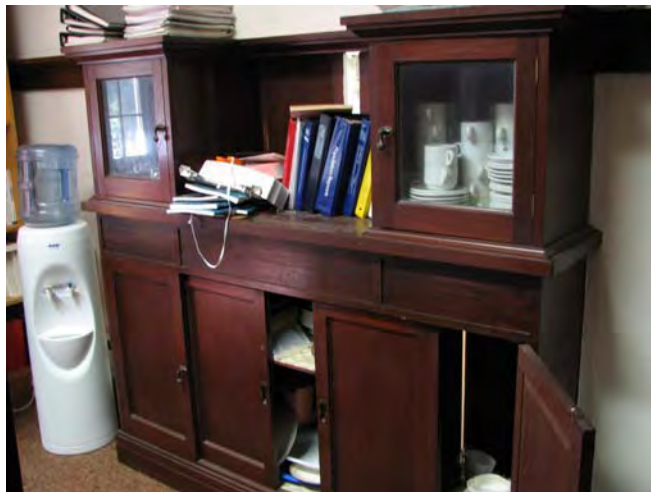
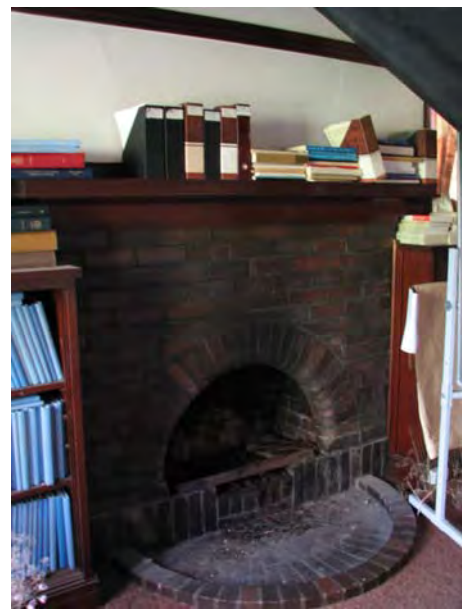
Figure 4.42: Important features (l-r) include the southern verandah, lounge room concertina doors, dining room servery and lounge room fireplace.

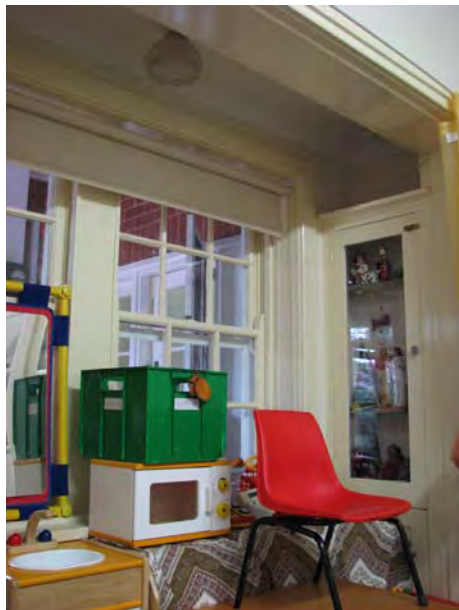
Figure 4.43:
The eastern bay window (left) and front doors.

The bay window to the right of the front door is an interesting feature. The seat has been retained as a storage compartment and is flanked with glazed cupboards. It is an arresting decorative feature which provides views of the front door portico (Figure 4.43).

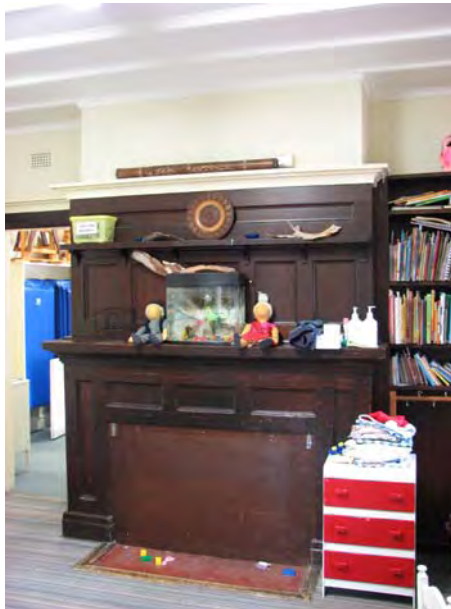
Figure 4.44: The sitting room fireplace and wood panelling has been damaged by unsympathetic services, but is relatively intact.

The fireplace in the sitting room has been retained, including the dark-stained surrounds and mantle (Figure 4.44). The surrounds are elongated sunken panels flanking smaller sunken panels at the top of the opening. The mantle is supported by chamfered brackets and surrounds the entire stack. Above is a smaller shelf with the assembly capped by a chamfered ledge running throughout the room. This provides a much more expressive, decorative character, as compared with the other basic picture rails throughout the residence. The room is lined with dark-stained timber panels and is in relatively good condition (minor scuff marks and damages). The window sills reflect the style of the mantle and shelving above.

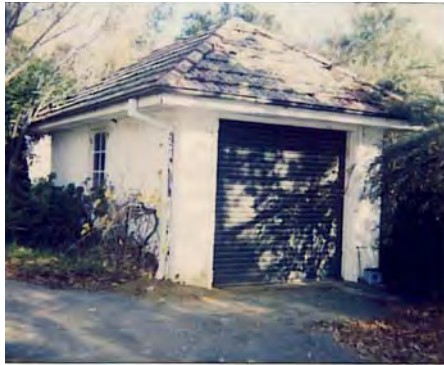
Figure 4.46:
The original garage (left) was demolished to make way for a cottage annex.

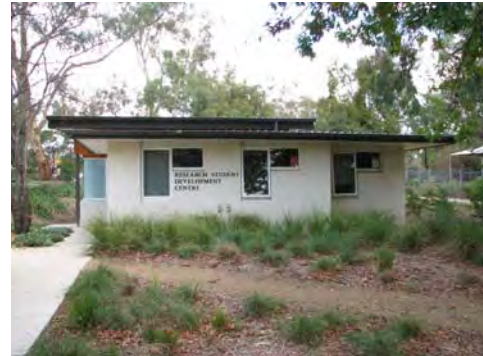
The original brick garage was removed by the University to make way for a larger cottage annex (Figure 4.46), which sits to the west of the building. It consists of five offices, a large meeting area and modern bathroom and kitchen amenities. The garage was of similar fabrics to the cottage and was well-suited to the site.

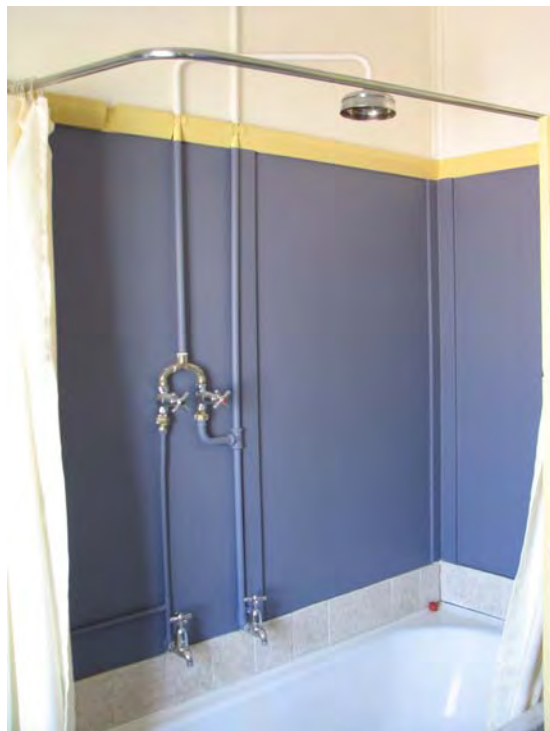
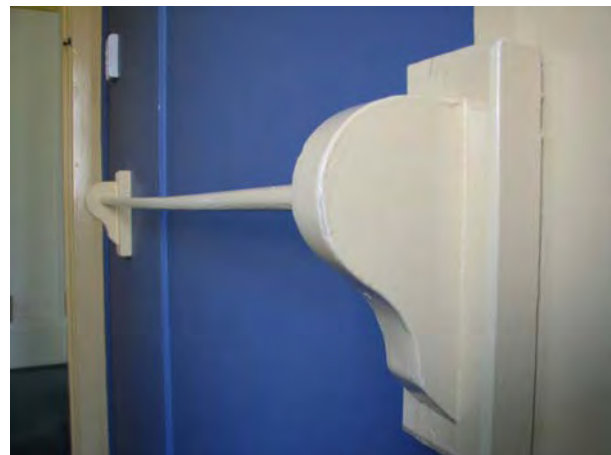
Figure 4.47: Intact bathroom features include the towel rail and exposed chrome plumbing.

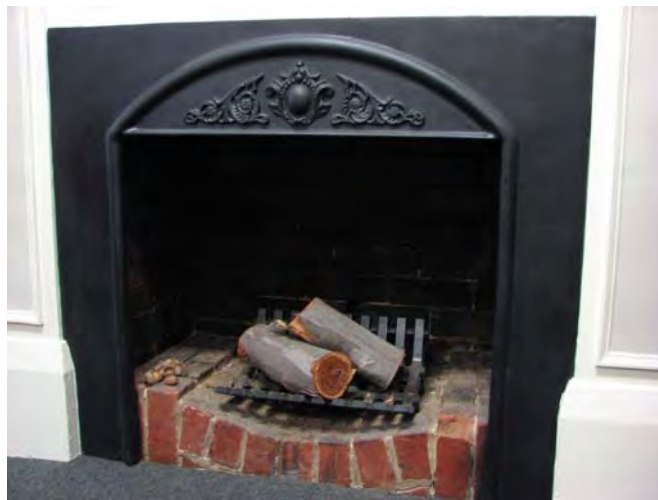
Figure 4.51: Sympathetic, yet arresting departures from the original: the front fireplace and change in cornice detail.

The skirtings change throughout, depending upon the extension, and with the cornices and picture rails, serve to differentiate the separate elements. The skirtings are an extended board with bevelled edge. Later examples also display a bevelled edge, yet are much narrower. The original cornices are a stepped chamfer and later moulds are a simple chamfered form.

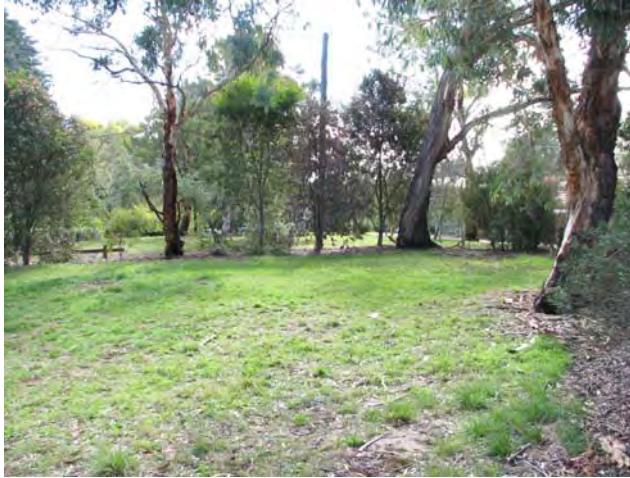
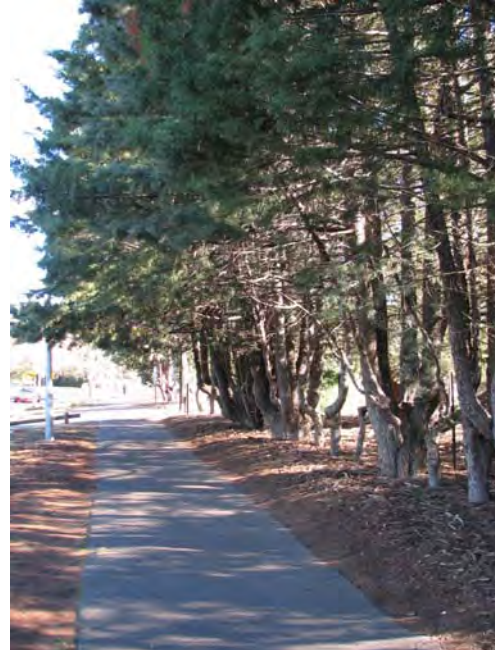
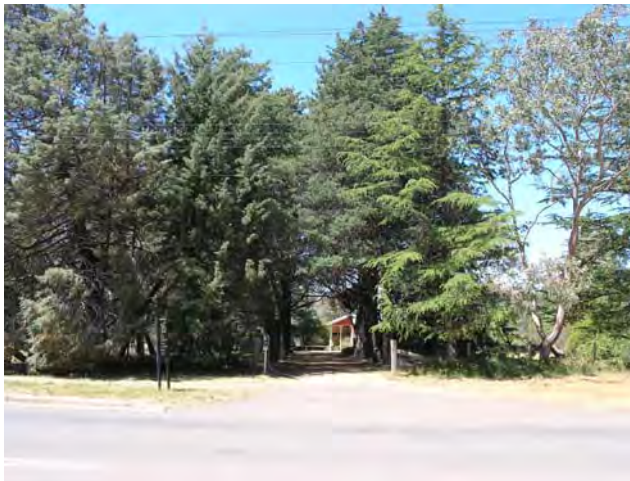
Figure 4.52: The cottages are separated by informal plantings (top left), with overgrown conifer species forming hedges along Liversidge Street (left and above).

The original front hedge (*cupressus* sp) have been retained at numbers 5 and 7 Liversidge Street, though have since matured and are a significant feature from the road. Mature hedges can be seen in other suburbs of Canberra, notably around the Deakin/Forrest areas, which were allowed to grow freely after the free hedge-clipping service was halted in 1954. Some remnant eucalyptus and later introduced evergreen species also survive between the buildings. The former gardens have largely been destroyed and replaced with carparking facilities, children's playgrounds or informal landscapes. The remnant garden trees of 9 Liversidge Street have been retained and today are exceptional examples of both introduced and indigenous species.

The landscape of the Acton Cottages has been altered considerably since they were originally formed, but glimpses of the past landscaping scheme can be seen in the remnant mature tree species and some last remaining hedges. Fences have been installed around the child-care centres and remain at numbers 8 Liversidge

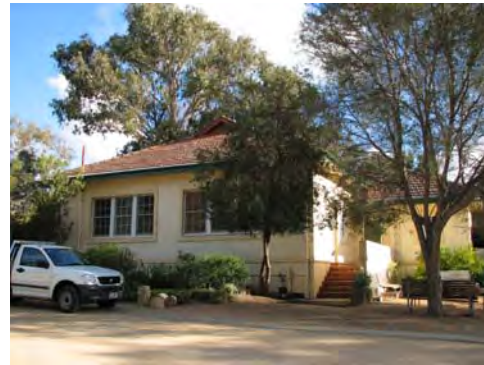
Gardener's Depot (office block), 2009

The building is generally in good condition and displays less signs of damage than the other hospital buildings at Acton. The skirting near the front door needs minor repairs, as do the kitchen walls (minor cracking). The original low cupboard in the meeting room, painted white, is reminiscent of the original fittings, and the layout of the building remains largely unaltered (a new partition has been added in the main tea room to provide for a change-area and locker space for the

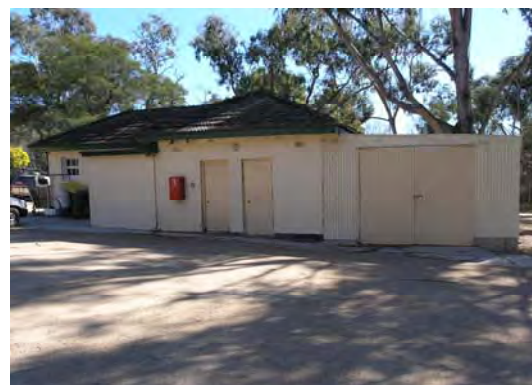
Figure 4.65: The Animal House, 2009. The holding pens, on the right of the building, have now been enclosed and used as vehicle store.
