4 CULTURAL FEATURES OF THE ACTON CONSERVATION AREA

The Acton Conservation Area consists of four main site complexes: Lennox House zone, Old Canberra House zone, Acton Cottages zone and the Old Canberra Community Hospital zone. The zones are illustrated in Figure 4.1.

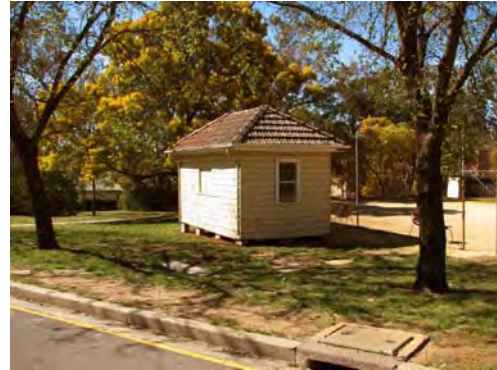
View northwest of tennis court and Auxiliary Canteen, 2009

The tennis court Canteen is a small single room construct with a rectangular floor plan that sits on concrete piers (recently replaced). The exterior is weatherboard and the hipped roof is clad with Marseilles-pattern roof tiles. Eaves are raked and lined with v-jointed boards. The gutter is quadrant with scotia mould trims beneath a square-dressed fascia.

The Canteen is in good condition, though has recently been vandalised and requires some repairs.

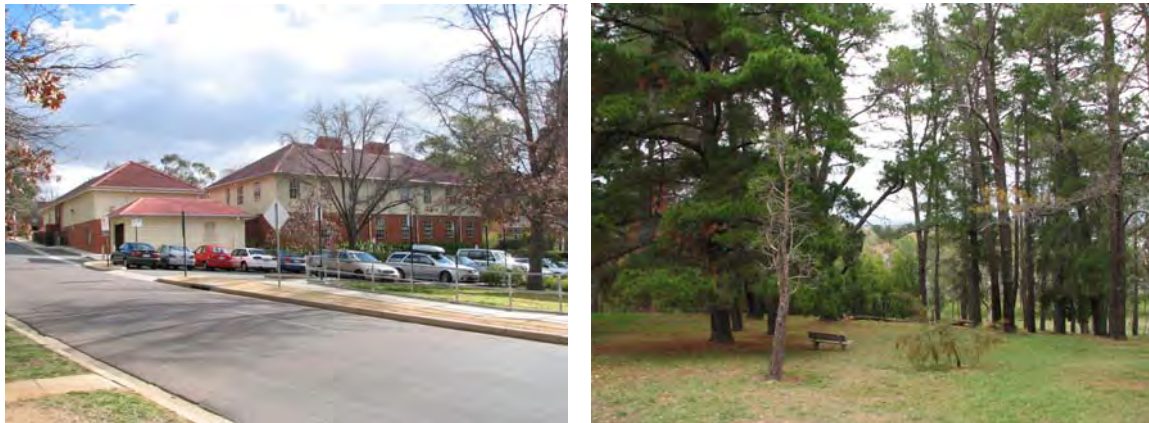
Weston plantings include a *Eucalyptus globulus* to the south of A Block and a number of pine specimens and remnant *E. melliodora* lining Mills Road. These are all mature specimens in fair-good condition. A significant *Schinus molle* can be seen to the north of N Block and an elm in the carpark to the east of M Block. A number of Weston-era *cupressus* have also survived in the landscape to the southwest of the Administration Block and are today still a useful wind-break from the Lake below and provide for pleasant surroundings.

Figure 4.70: Though much of the vegetation has been removed around the Old Hospital Buildings, a number of significant species have been retained, including those around the carparking areas (left), and in the landscape to the south/west of the Administration Block.

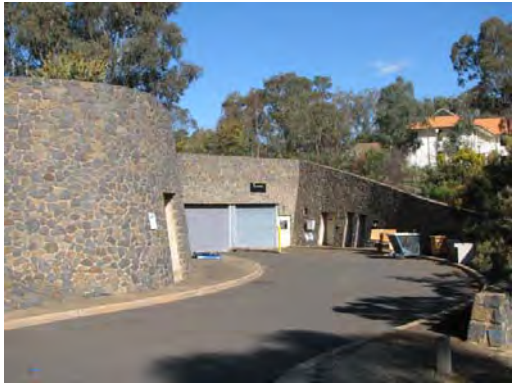
<p data-bbox="868 770 1267 799">The entrance to the Tunnel, 2009</p>

The Tunnel has seen numerous alterations, with some remnant signs of earlier walls or fittings still visible. However, given the bare utilitarian nature of the original form these changes are not noteworthy. No damages were observed during recording, although it is known that water has seeped into the Tunnel from nearby pipes in the past. This is a prime concern for any area with a controlled environment for the storage of sensitive and fragile papers; the pipes were replaced and damages repaired.

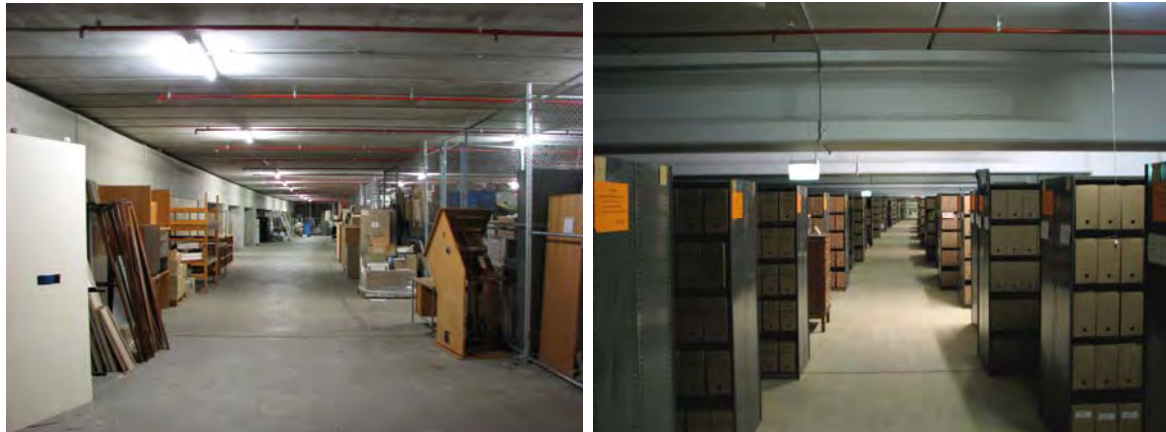
Figure 4.73: Though designed as a carpark, the Acton Tunnel is used for general storage purposes (left) and as the repository of the ANU Noel Butlin Archives Centre (right).

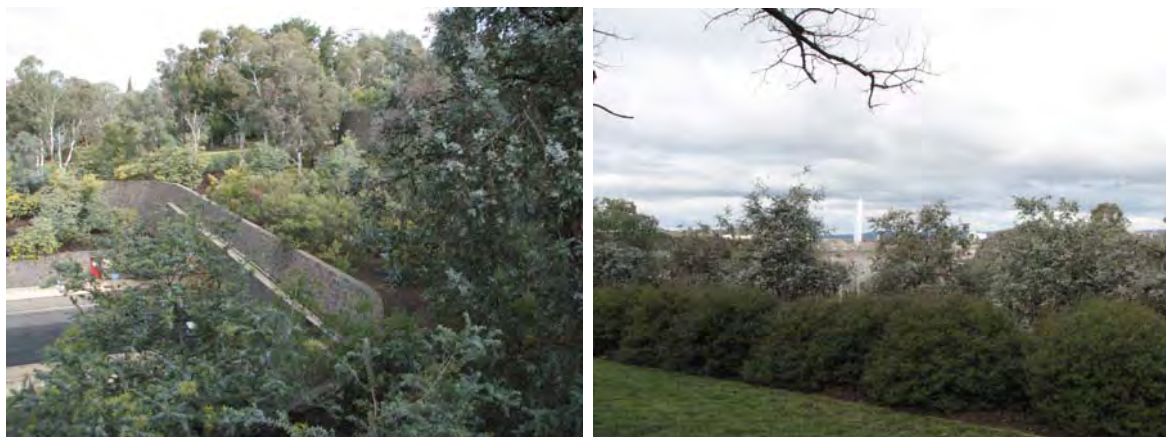
The vegetation above the Tunnel is a poor reflection of that seen in the rest of the Acton Conservation Area. The landscape of this area “is typical of the municipal landscape approach adopted by the NCDC” and has been largely unsuccessful, likely due to the poor quality of the backfill over the Tunnel and to changed water table and drainage patterns. The species used include grevilleas and wattles, are short-lived and have been replaced where necessary. The choice of species forms a strong discontinuity between the Old Canberra House/Lennox House zones and the residential zone to the north, acting as a low-impact ‘buffer zone’. The stunted vegetation has also resulted in the retention of a number of significant views from the site that would have otherwise been obscured.

Figure 4.74: The low vegetation above the Tunnel provides for some of the last significant views from the Acton area.
