Heritage Management Plan

LENNOX HOUSE

Lennox House – I Block

February 2009

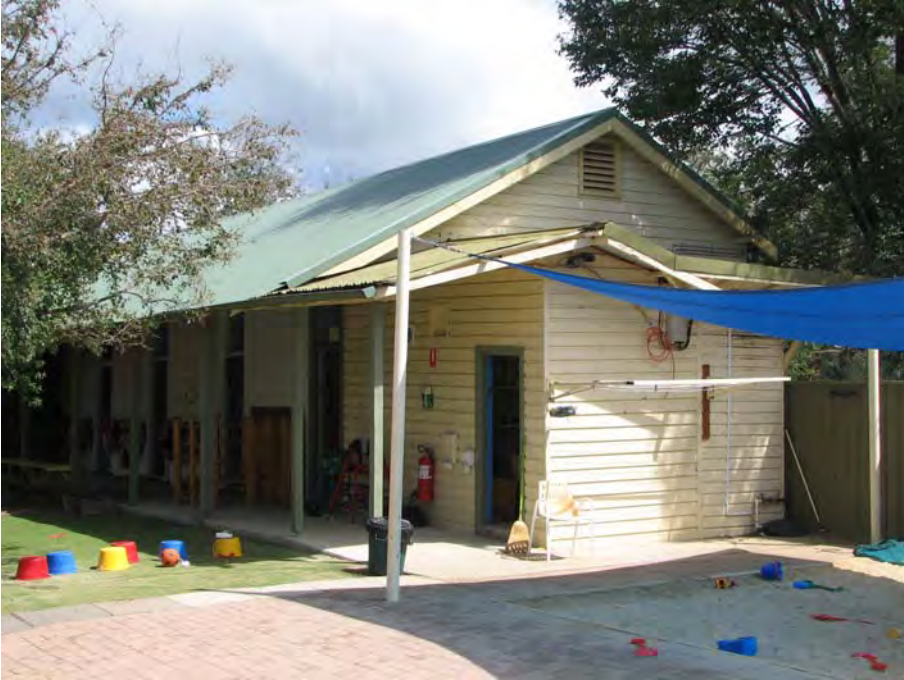
Plate 4: D Block; north side. Note replacement roofing (JAA 2007)

Block D is in good condition. Much of the original fabric remains, but the noticeable changes are the concrete floor slab to the verandah, and the replaced verandah posts. Some items of work required to the exterior of the fabric of the building were carried out in 1998. The building has been repaired after termite infestation in the floor and part of the walls. New roofing has been provided.

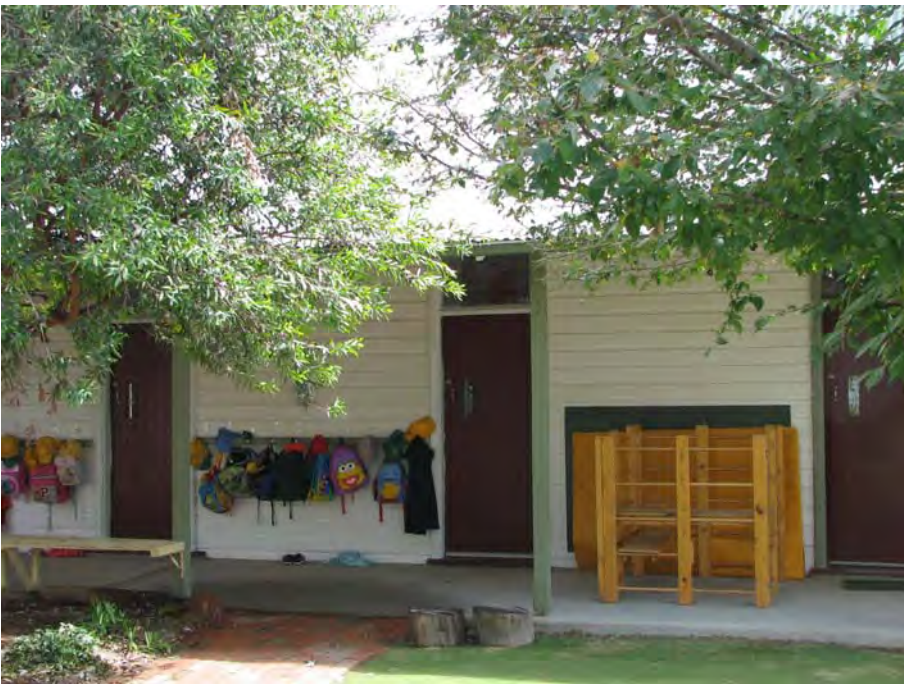
Plate 5: D Block; east side. The HMP recommends replacement of the concrete floor and posts (JAA 2007)

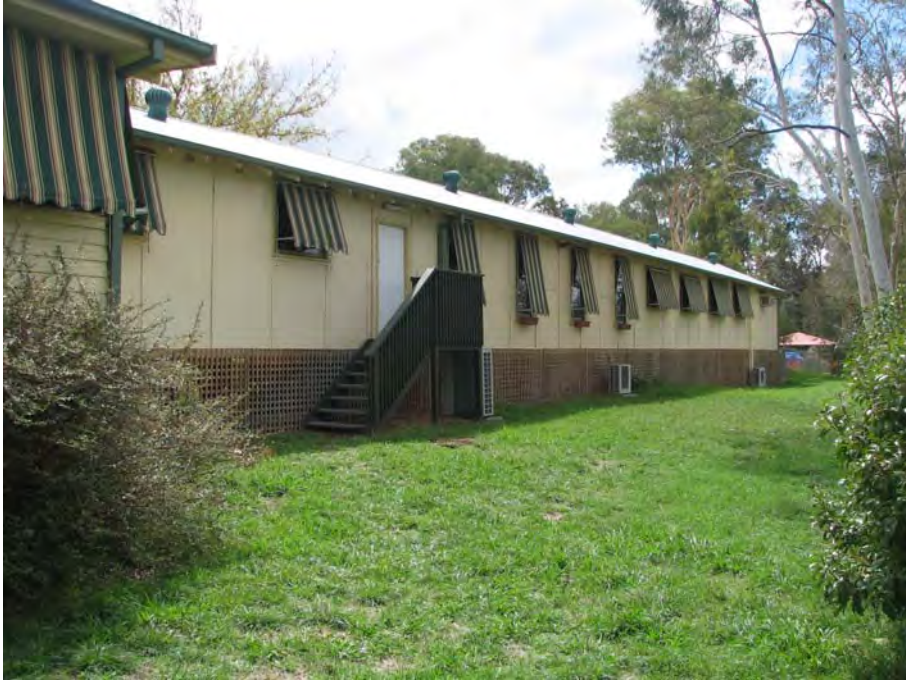
Plate 6: E Block; east side. The HMP supports the removal of this building, but not at the prejudice of the Child Care Centre (JAA 2007)

This report recommends the eventual removal of Block E, and this will have an obvious impact on the ANU Pre-School and Child Care Centre.

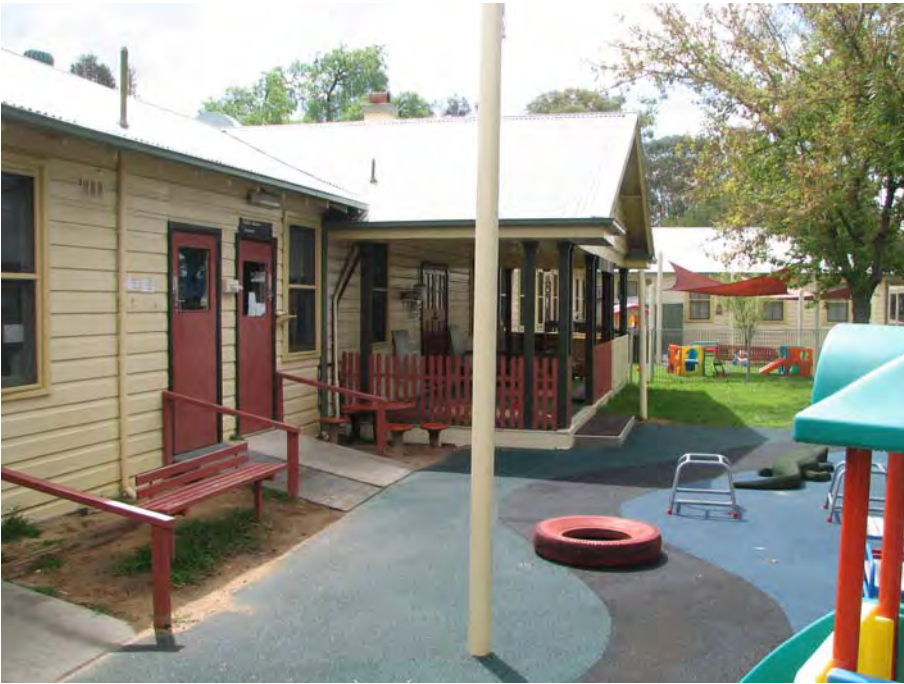
Plate 8: F Block; east side. This aesthetically important elevation is obscured from view by E Block (JAA 2007)

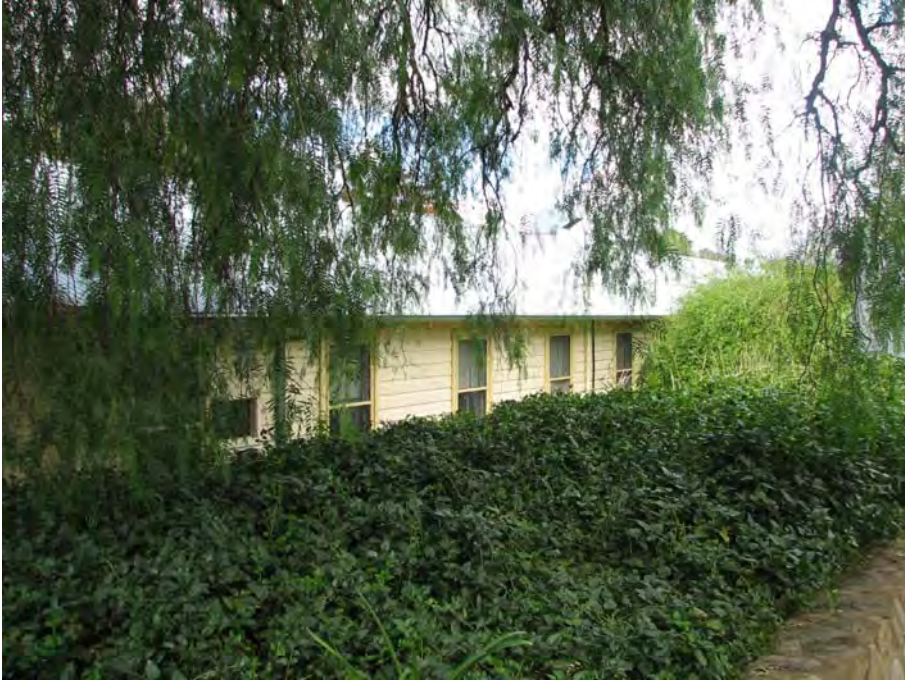
The rusticated weatherboards are 230mm deep and are painted grey under the present cream colour, which is badly weathered (Plate 10).

Plate 10: F Block; west side. The remnant stone wall under the overgrowth has heritage significance (JAA 2007)

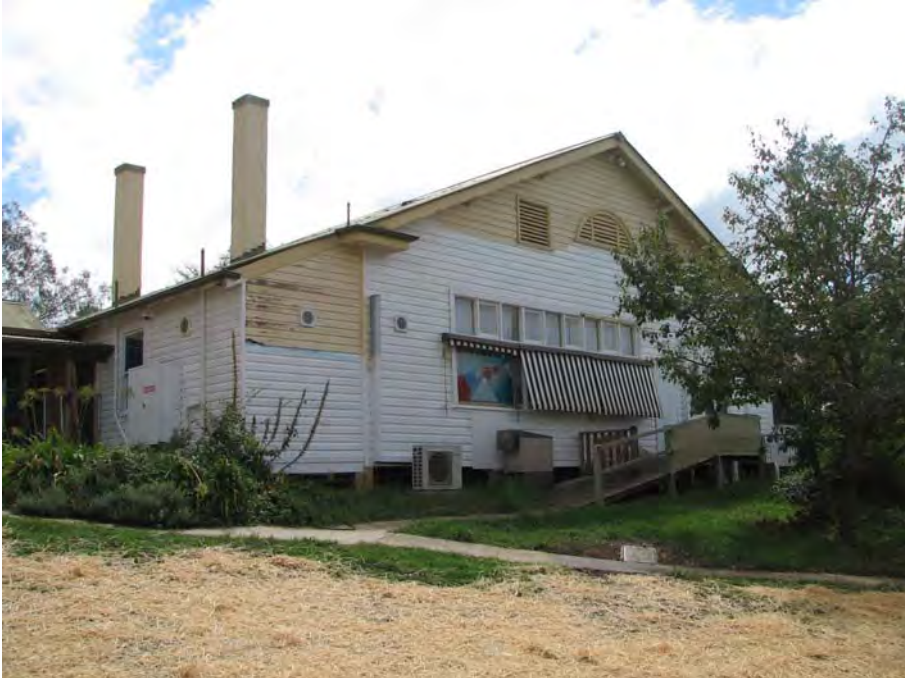
Plate 11: G Block; east side. This elevation was built in the late 1920s (see Plate 1 for original appearance) (JAA 2007)

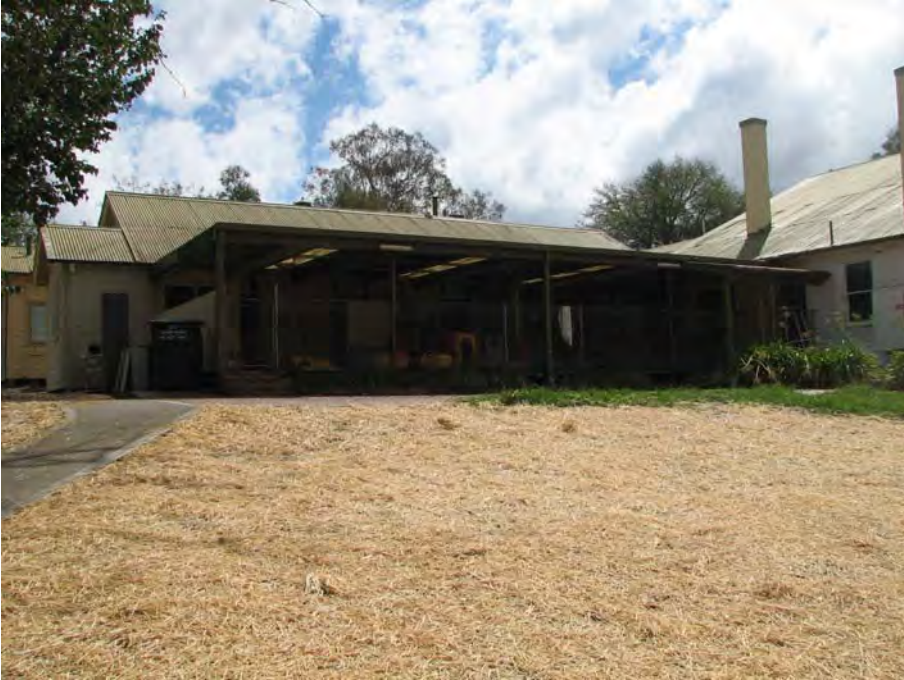
Plate 12: H Block; south-west side. The building is largely obscured by the covered deck (JAA 2007)

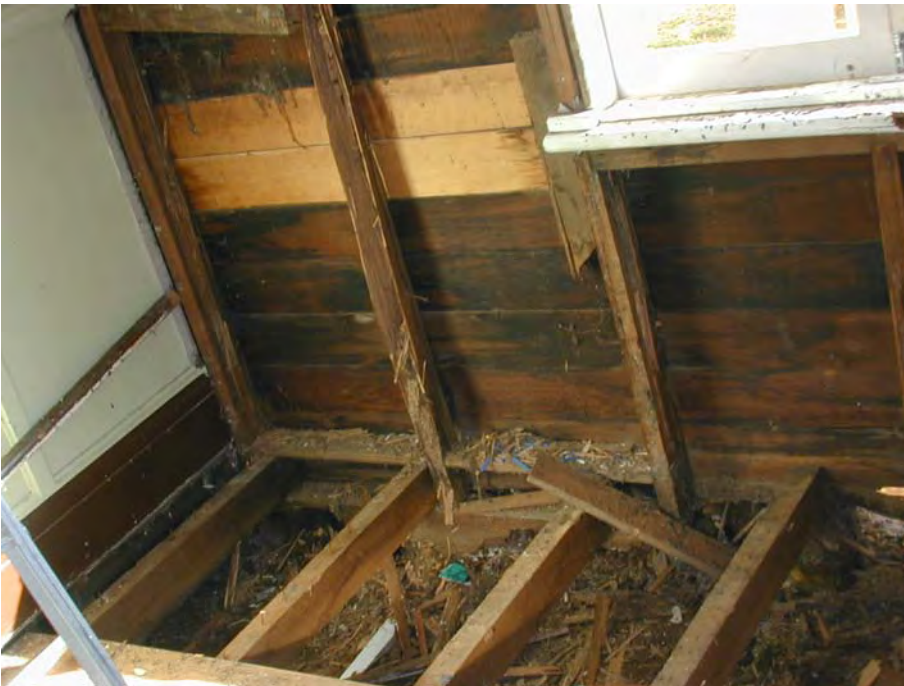
Originally, the interior consisted of five rooms, each leading off the verandah. Walls have been removed to enlarge these rooms, but nibs and bulkheads remain to explain the original configuration. The interior has a timber floor, which has been extensively repaired after termite damage (Plate 24). The verandah has a modern concrete floor.

Plate 24: Block D – damages as a result of termite infestation (JAA 1998)

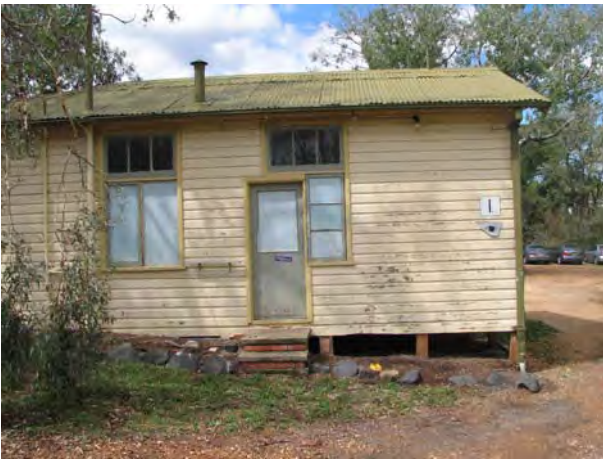
Plate 34: Block I; west end. Note the crude installation of the door into the partly demolished window (JAA 2007)

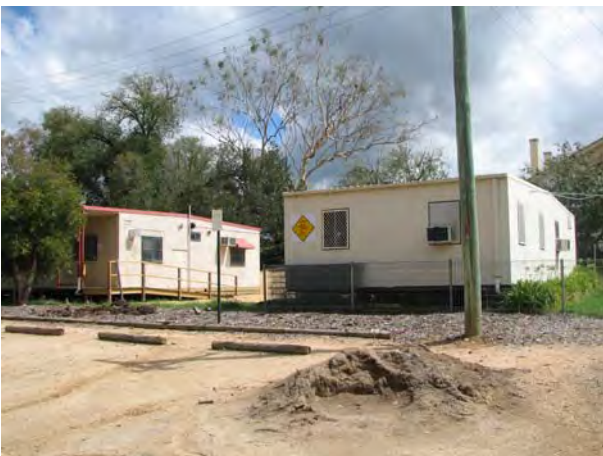
Plate 35: Temporary demountables. These are intrusive and should not be considered long-term facilities (JAA 2007)

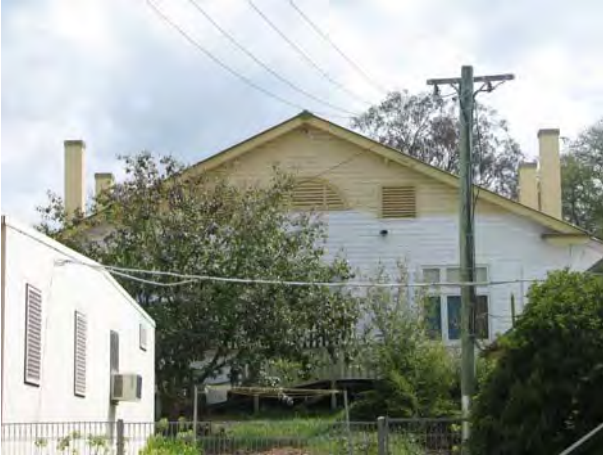
Plate 36: Block G; east façade. This was added in the 1920s, with little regard for the original symmetrical façade (JAA 2007)

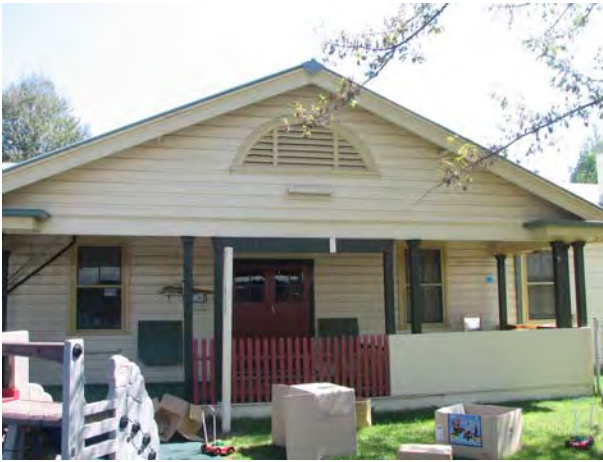
Plate 37: Block F; east façade. Original portico overlooked the river flats. The view is now obscured by Block E (JAA 2007)

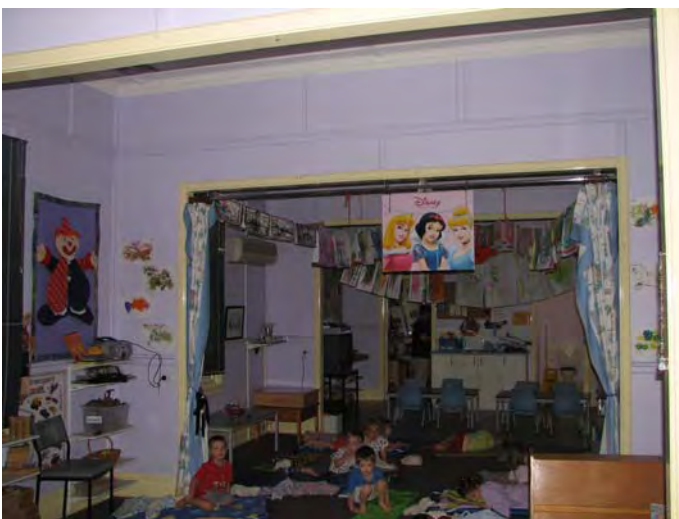
Plate 38: Block D; interior view showing nib walls and bulkheads to identify former individual bedrooms (JAA 2007)

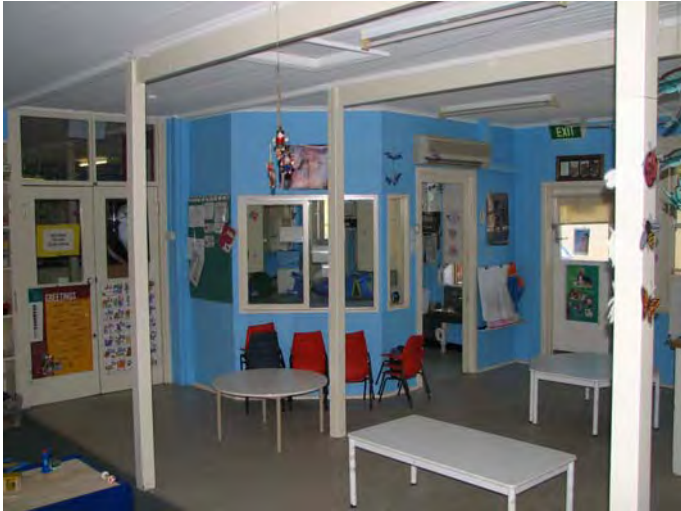
Plate 39: Block F. large interior spaces have been formed with the removal of inner walls. The posts and some bulkheads remain to identify the earlier configuration of rooms (JAA 2007)

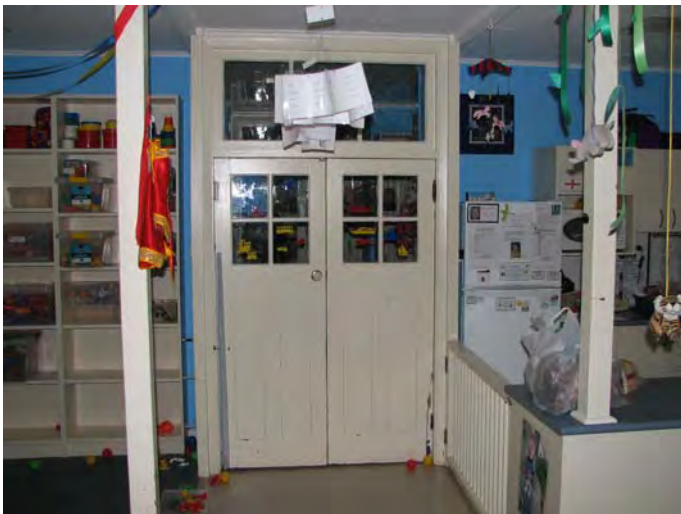
Plate 40: Block F. original doors and other joinery details survive aside the colourful presence of child-care activity (JAA 2007)

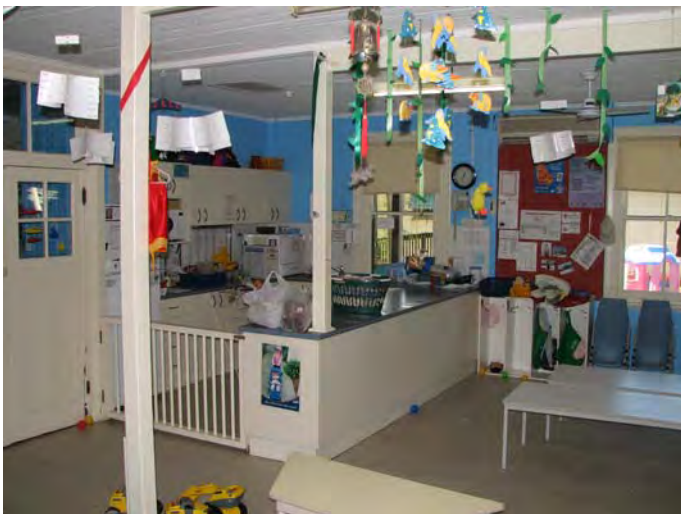
Plate 41: Block F. Modern joinery and other equipment has been fitted within the historic fabric, with adverse impact (JAA 2007)

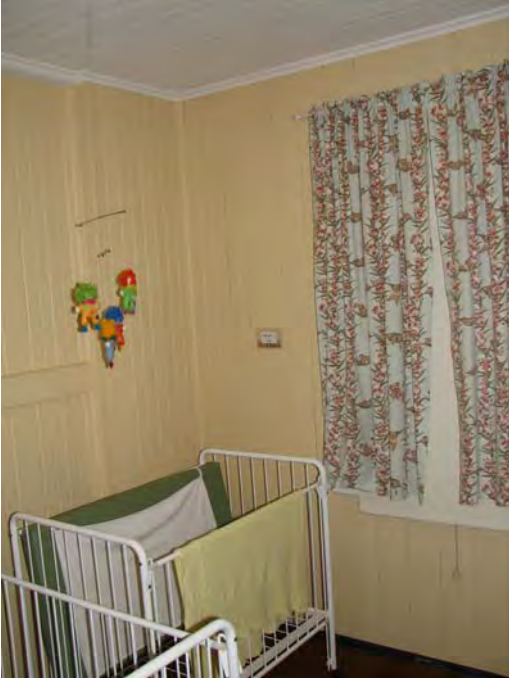
Plate 42: Block F. Cot room within an original bedroom. The timber walls and ceiling survive, and are significant elements of the interior (JAA 2007)

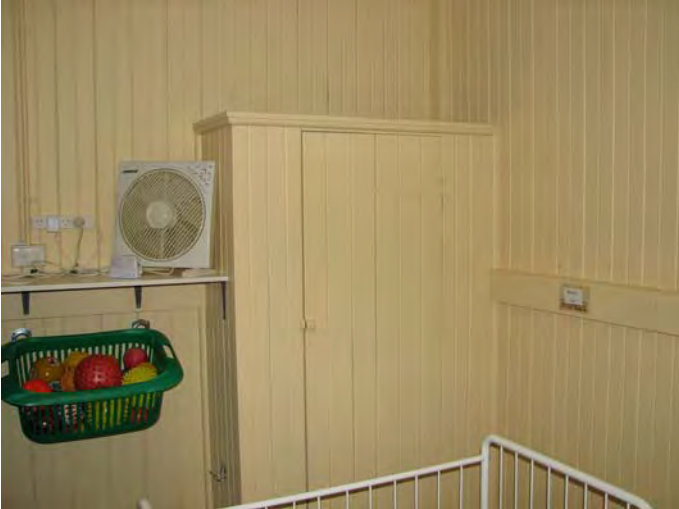
Plate 43: Block F. A surviving built-in cupboard. There are many of these throughout Lennox House, and should be retained (JAA 2007)

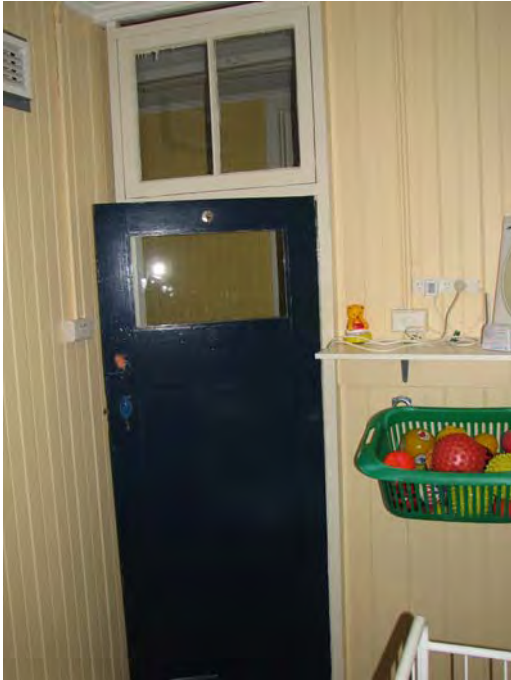
Plate 44: Block F. Typical bedroom door with transom window. These items and details should be retained (JAA 2007)

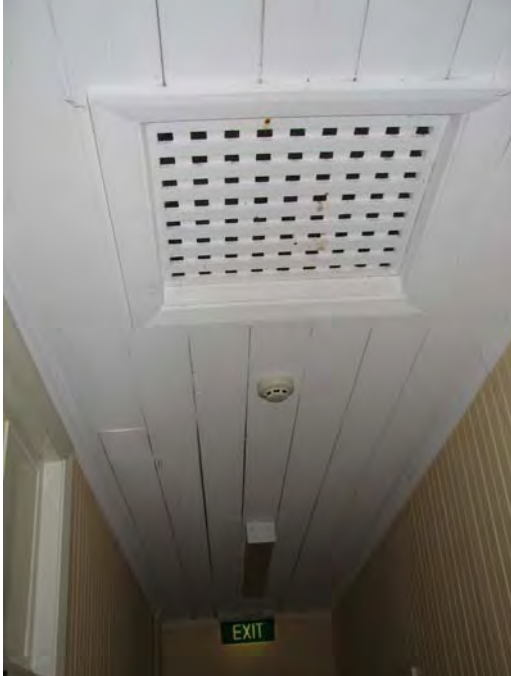
Plate 45: Block F. Roof vent demonstrating the natural ventilation applied to the design of the building. Note also the surviving timber ceiling (JAA 2007)

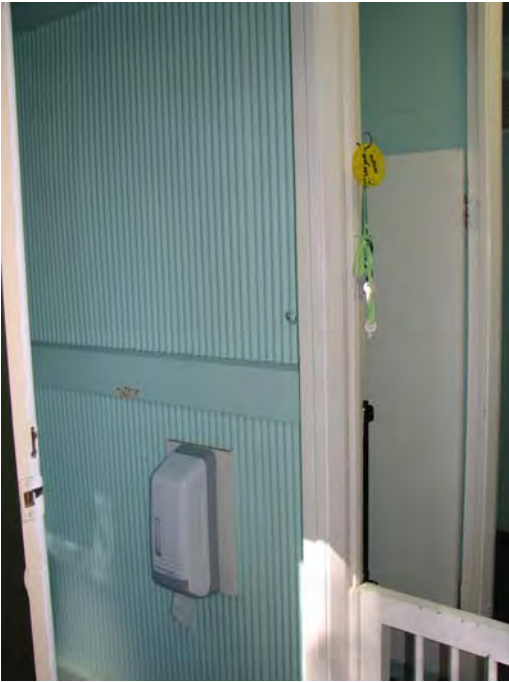
Plate 46: Block F. Ripple-iron toilet linings. These features must be conserved and retained (JAA 2007)

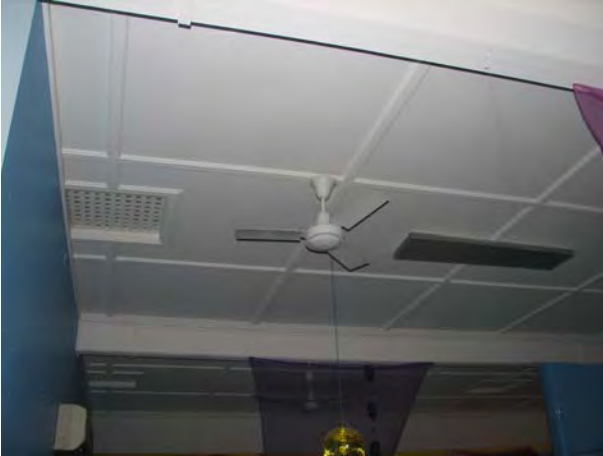
Plate 50: Block G. Dining room ceiling, with intact details including strapping and vents. These should be retained (JAA 2007)

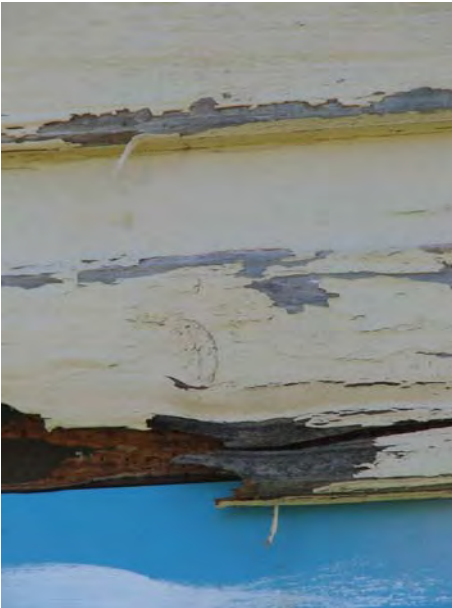
Plate 51: Block G. Exterior view of weathered paint. It appears that the original colour on the walls was a traditional cream (JAA 2007)

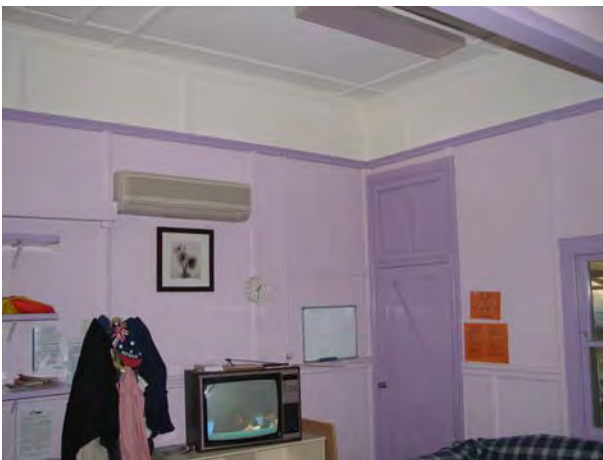
Plate 52: Block H. The staff room is formed by the removal of bedroom walls (see bulkhead above). Note the original braced and ledged door, picture rails, strapping and wall details. All of these elements are to be retained (JAA 2007)

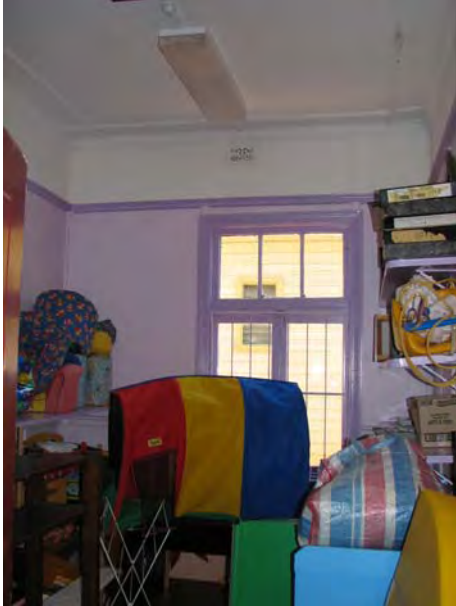
Plate 53: Block H. Store room with many original features of the building intact (JAA 2007)

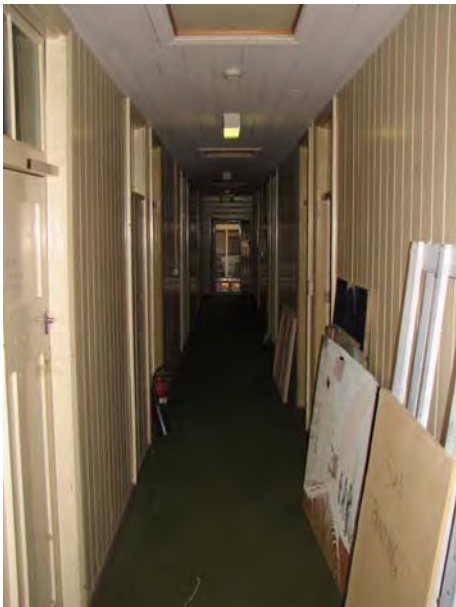
Plate 54: Block A. The central corridor extends the full length of the building. The timber walls, ceilings, door jambs, transom windows and timber trim are highly intact. This building is not one of the earliest Lennox House buildings, but lends itself to a high degree of conservation (JAA 2007)

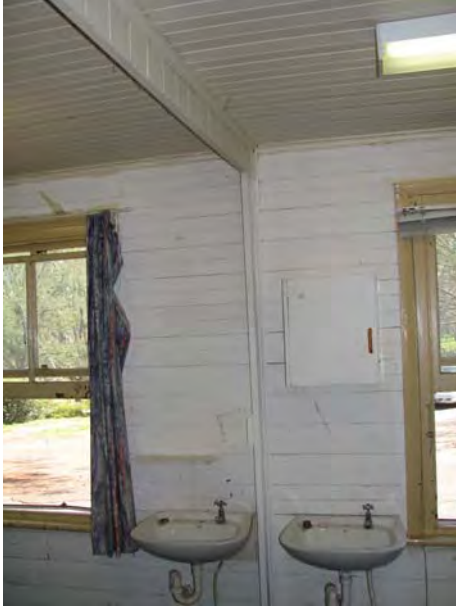
Plate 55: Block A. A wall separating two original bedrooms has been removed, but a bulkhead and nibs have been retained to identify the earliest arrangement. All bedrooms had basins, but those in the picture are not original (JAA 2007)

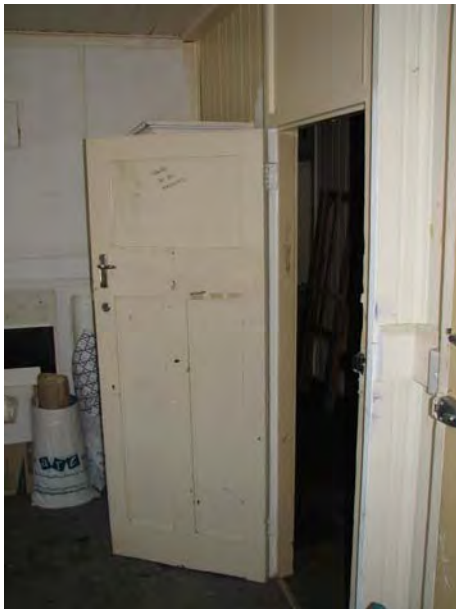
Plate 56: Block A. Typical high-waisted bedroom door with three panels. Note the door jamb is expressed and has the dual function of wall frame and door jamb. These functions would normally be provided with two separate timbers (JAA 2007)
